MECHANICAL AND MICROSTRUCTURAL/CHEMICAL DEGRADATION
OF COATING AND SUBSTRATE IN GAS TURBINE BLADE

Y. Sugita*, M. Ito*, S. Sakurai#, C. R. Gold+, T. E. Bloomer+ and J. Kameda+

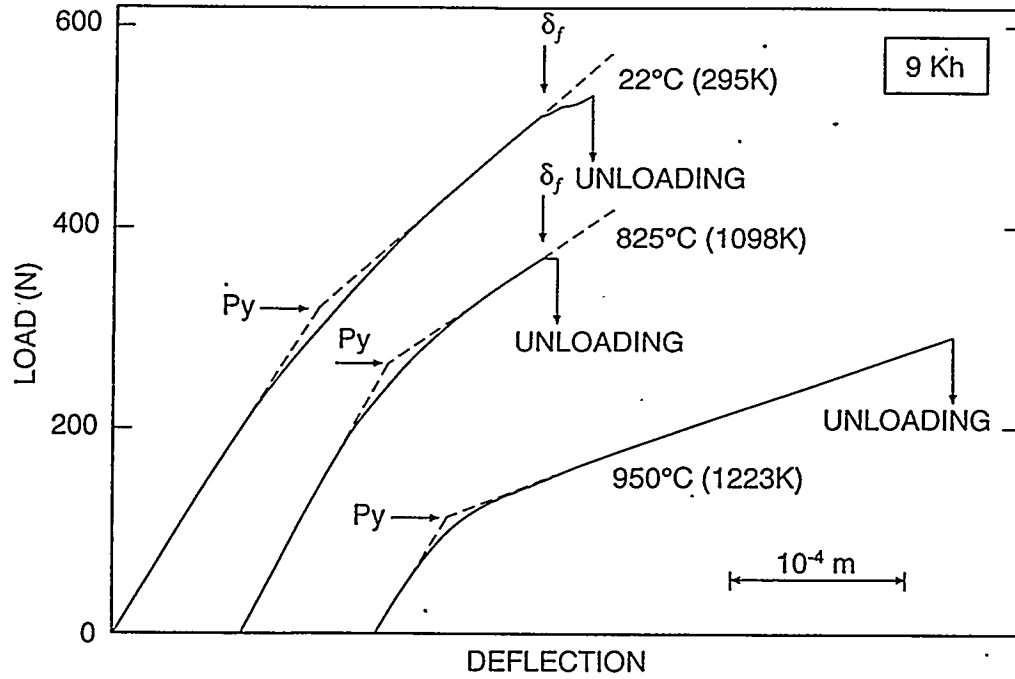
Figure 1 shows typical load vs. deflection curves obtained from SP tests on the 9Kh coating specimens at 295 K, 1098 K and 1223 K. A reduction in the loading rate or level off of the load was observed at the critical deflection in the coating and substrate SP specimens. SEM observation on load-interrupted SP specimens at different load levels confirmed that the critical deflection is indicative of crack initiation (4,5). In some coating specimens tested at 1173 K and 1223 K, the formation of ductile cracks was found to cause no changes in the load vs. deflection curve (Fig. 1). In addition, it is shown (4,5) that the yield strength of the coatings decreased with increasing operating time and all the coatings greatly softened at 1223 K.

Figure 1. Typical load vs. deflection curves obtained from SP tests on 9Kh SP coating specimens at 295 K, 1098 K and 1223 K.

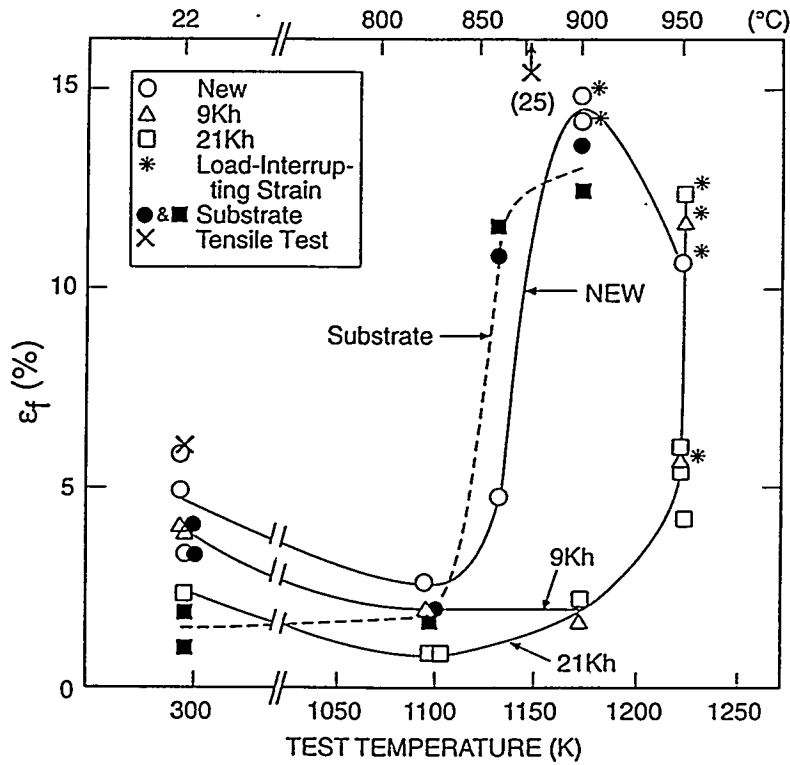
The temperature dependence of ϵ_f observed in the coating and substrate specimens is indicated in Fig. 2. The data with asterisks mean the strain value at the load-interrupting stage where ductile cracks extended a size of 100-200 μm . Increasing the operating time led to a reduction in the ductility of the coating and substrate at 295 K. All the coatings and unused substrate had lower ductility at 1098 K, compared with those at 295 K. The ductility of the coating and substrate increased with further increasing testing temperature and the ductile-brittle transition behavior was observed. The ductile-brittle transition temperature (DBTT) of the coatings was shifted to higher temperature by 90 K, as a result of the long time operation. The DBTT of the substrate did not change in-service, which remained slightly lower than that of the unused coating. It should be noted that the SP test of the unused substrate demonstrated lower ductility than the tensile test. This finding would be ascribed to the biaxial stress state in the SP test which promotes cracking.

Figure 2. Temperature dependence of fracture strain (ϵ_f) obtained from SP tests on new and used coatings and substrates, compared with tensile test results.

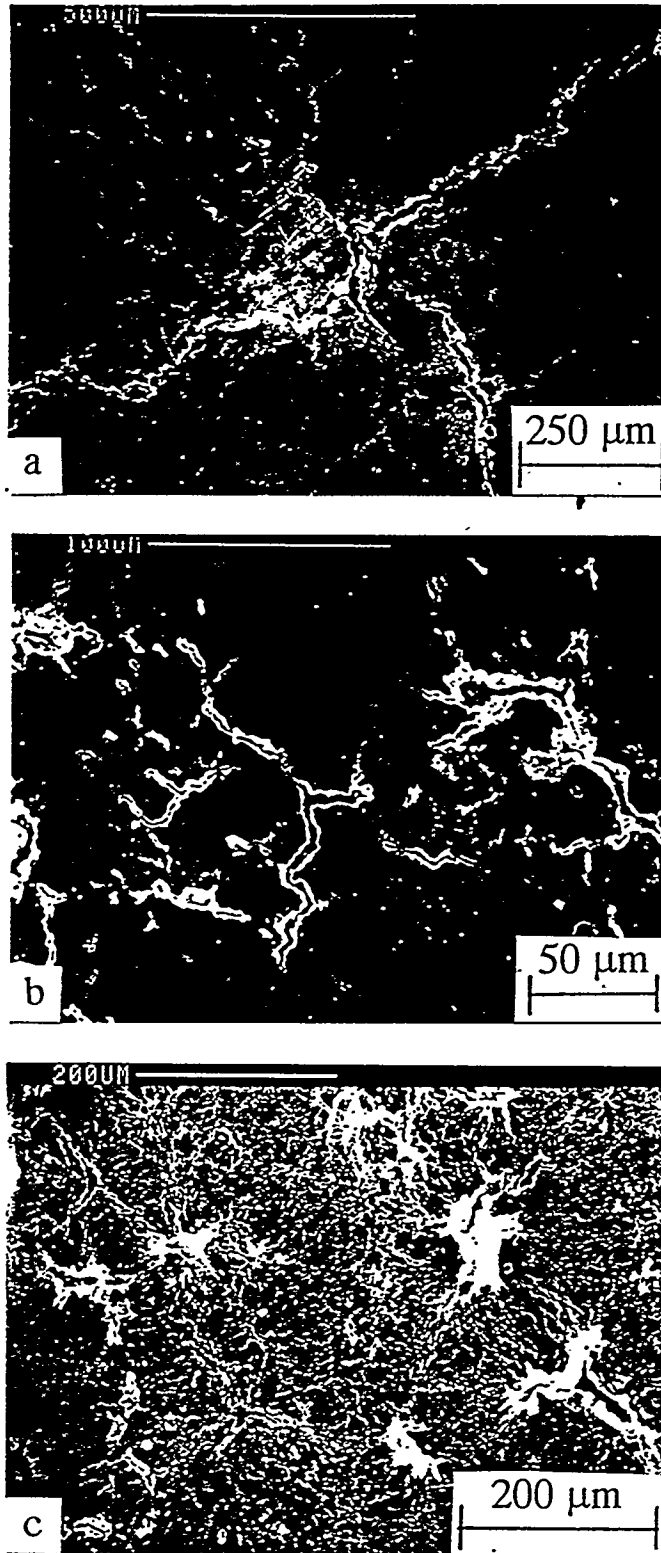
The morphology of coating cracking in SP specimens deformed just above δ_f is shown in Fig. 3. At 295 K, brittle cracks initiated at the center of coating SP specimens and propagated a distance of about 500-1000 μm along the radial direction (Fig. 3a). In SP tests at 1098 K on all the SP specimens, a number of coating cracks were heterogeneously nucleated and discretely grew along either the radial or tangential direction (Fig. 3b). The extension of brittle cracks (50-250 μm) at 1098 K became considerably smaller, compared with that at 295 K. The used coatings revealed longer cracks and a higher crack density than the new coating at 1098 K. Ductile cracks in the unused coating were highly localized near the specimen surface and propagated in a zigzag mode (4,5). In the 9Kh coating strained up to 6 %, as can be seen in Fig. 3c, several coating cracks were initiated at oxides, which had been formed during the operation, and the nucleated cracks extended into the coating matrix accompanied by some crack tip opening.

Figure 3. SEM micrographs of cracking morphology (a) at 295 K in unused coating, (b) at 1098 K in 21Kh coating and (c) 1223 K in 9Kh coating.

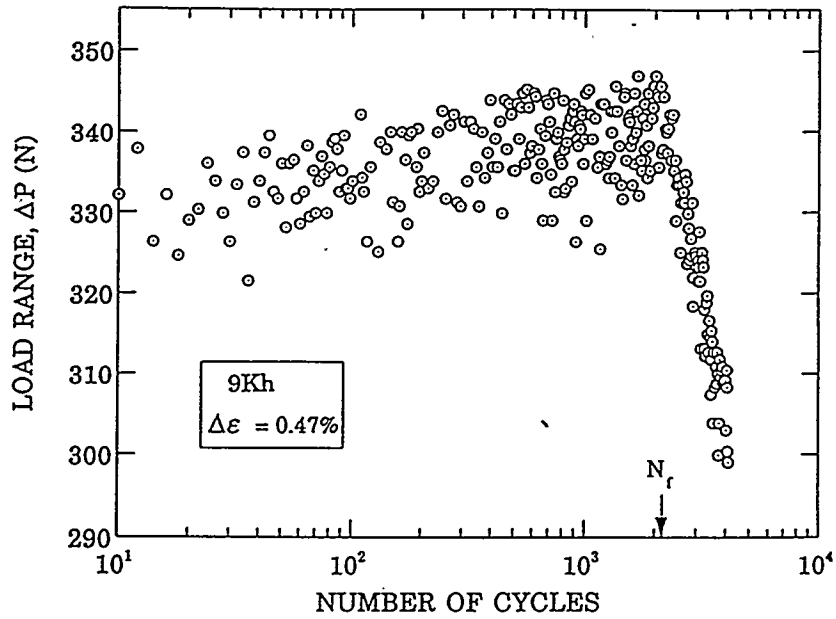
The LCF behavior of the unused and used coatings was studied using the SP testing technique. Figure 4 indicates the relationship of ΔP to the number of fatigue cycles at the strain range $\Delta\varepsilon = 0.47$ % for the 9Kh coating. The value of ΔP showed +3 % variations. Hardening behavior was observed during LCF in many cases. The formation of coating cracks along the radial direction resulted in a sharp drop in ΔP at the critical number of cycles (N_f) (Fig. 4). Some SP tests showed a gradual load decrease during LCF because of discrete formation of cracks. In such cases, the upper and lower bounds of ΔP provided different values of N_f and the range of N_f was determined (see bars in Fig. 5). The logarithmic plot between N_f and $\Delta\varepsilon$ suggests an empirical relationship, i.e., $N_f = C (\Delta\varepsilon)^{-4.1}$, although some data scattering can be observed (Fig. 5). The power obtained in the present SP tests is a little higher than that in hollow cylinder tests at high temperatures (8). The LCF life tends to decrease, i.e., lowering the value of C , as a result of the long time operation.

Figure 4. Variation of load range with number of fatigue cycles at $\Delta \epsilon = 0.47\%$ in 9Kh coating.

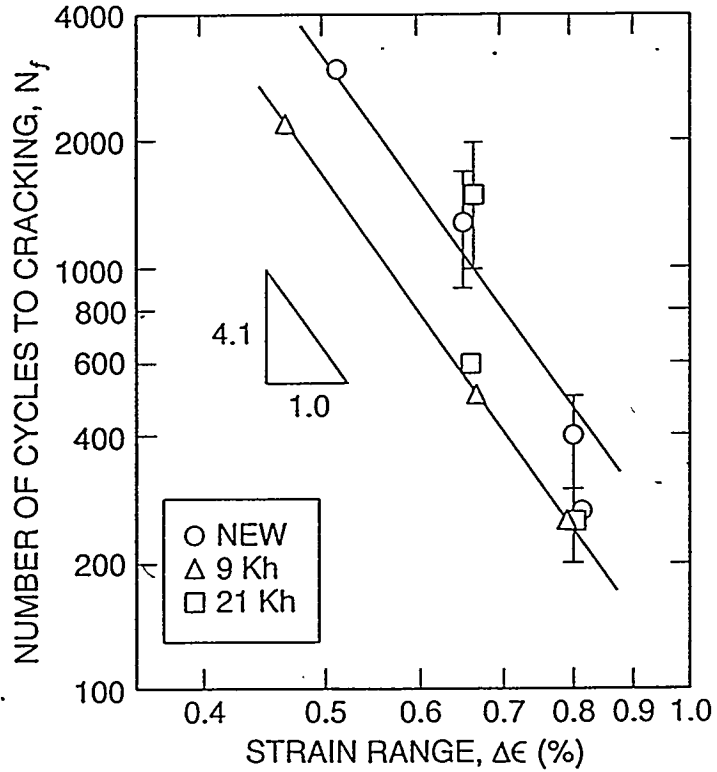
Figure 5. Logarithmic relationship between number of fatigue cycles to coating cracking (N_f) and strain range ($\Delta \epsilon$).
