EVALUATION OF LASER-GLAZED PLASMA-SPRAYED THERMAL BARRIER COATINGS UNDER HIGH TEMPERATURE EXPOSURE TO MOLTEN SALTS

C. Batista^{a,*}, A. Portinha^a, R. M. Ribeiro^a, V. Teixeira^a and C.R. Oliveira^{b,c}

^a University of Minho, Physics Department, Campus de Gualtar, 4710-057 Braga, Portugal,

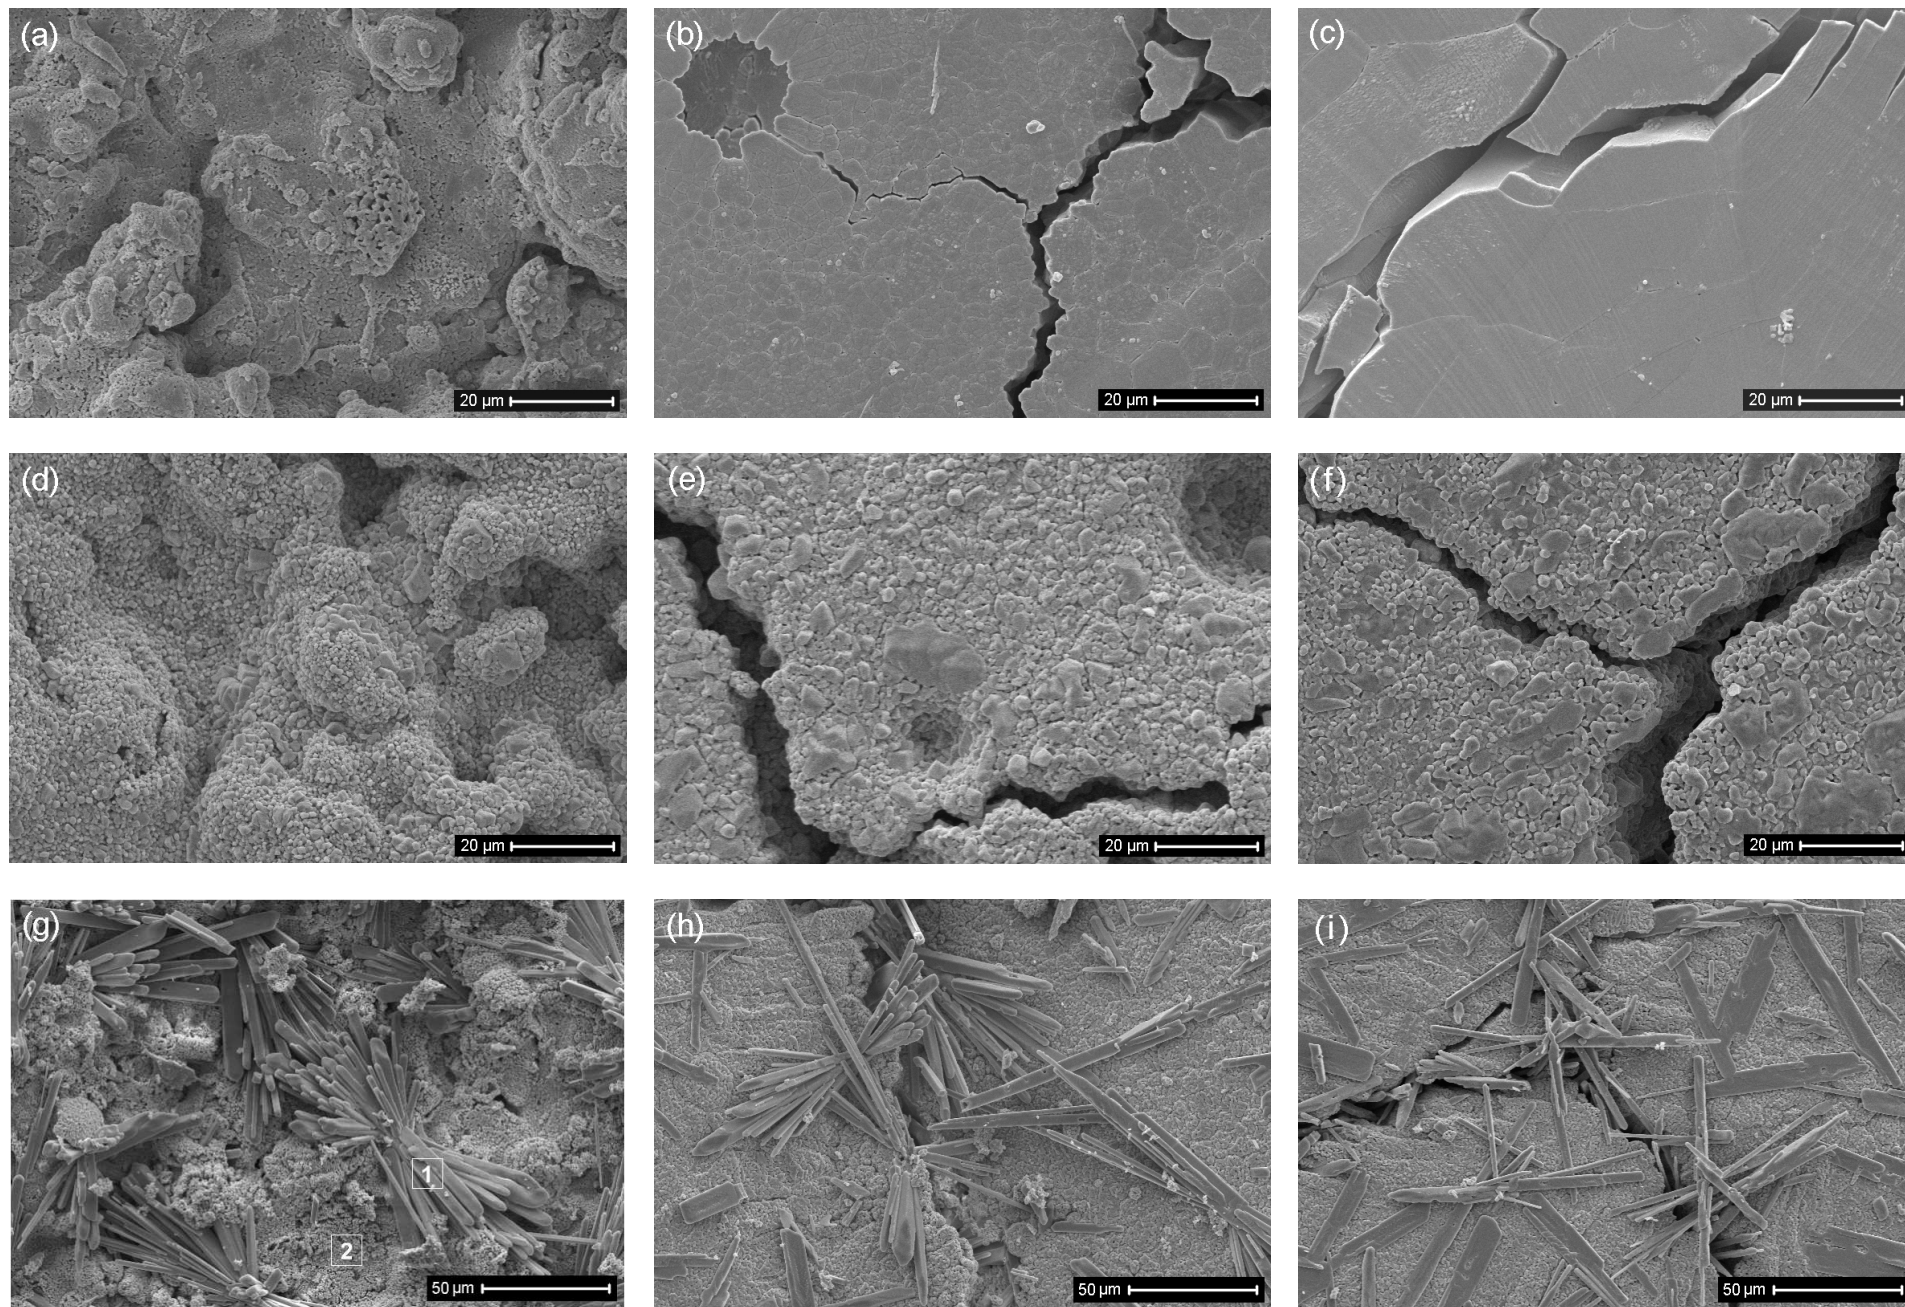
Fig. 2

Specimens tested with Na_2SO_4 (Fig. 2a,b,c) did not show visible signs of degradation of the initial surface morphology although a slight increase of porosity has been noticed for the as-sprayed condition specimen (Fig. 2a). Moreover, no Na- or S-containing products have been found at the surface by EDS probably due its low content below the detection limit of the XRD diffractometer.

Specimens tested with V_2O_5 (Fig. 2d,e,f) or $\text{V}_2\text{O}_5+\text{Na}_2\text{SO}_4$ (Fig. 2g,h,i) presented their surfaces highly porous and in particular those in the as-sprayed condition (Fig. 2d,g). The as-sprayed coating tested with $\text{V}_2\text{O}_5+\text{Na}_2\text{SO}_4$ was extremely damaged and showed significant amounts of detached material (Fig. 2d). In specimens corroded by $\text{V}_2\text{O}_5+\text{Na}_2\text{SO}_4$, lace-like agglomerates of crystals were found. The crystals presented a high aspect ratio with needles up to 100 μm long. On the other hand, specimens corroded solely by V_2O_5 only showed irregular crystals embedded on the surface (Fig. 2d,e,f). It was found by EDS analysis (Fig. 3) that the crystals in both cases were composed of yttrium, vanadium and oxygen and confirmed to be YVO_4 by XRD analysis.

Fig. 2. SE micrographs illustrating the surface view of coatings after the hot corrosion test: (a) Sprayed-Na₂SO₄; (b) CO₂-Na₂SO₄; (c) YAG-Na₂SO₄; (d) Sprayed-V₂O₅; (e) CO₂-V₂O₅; (f) YAG-V₂O₅; (g) Sprayed-MIX; (h) CO₂-MIX; (i) YAG-MIX.

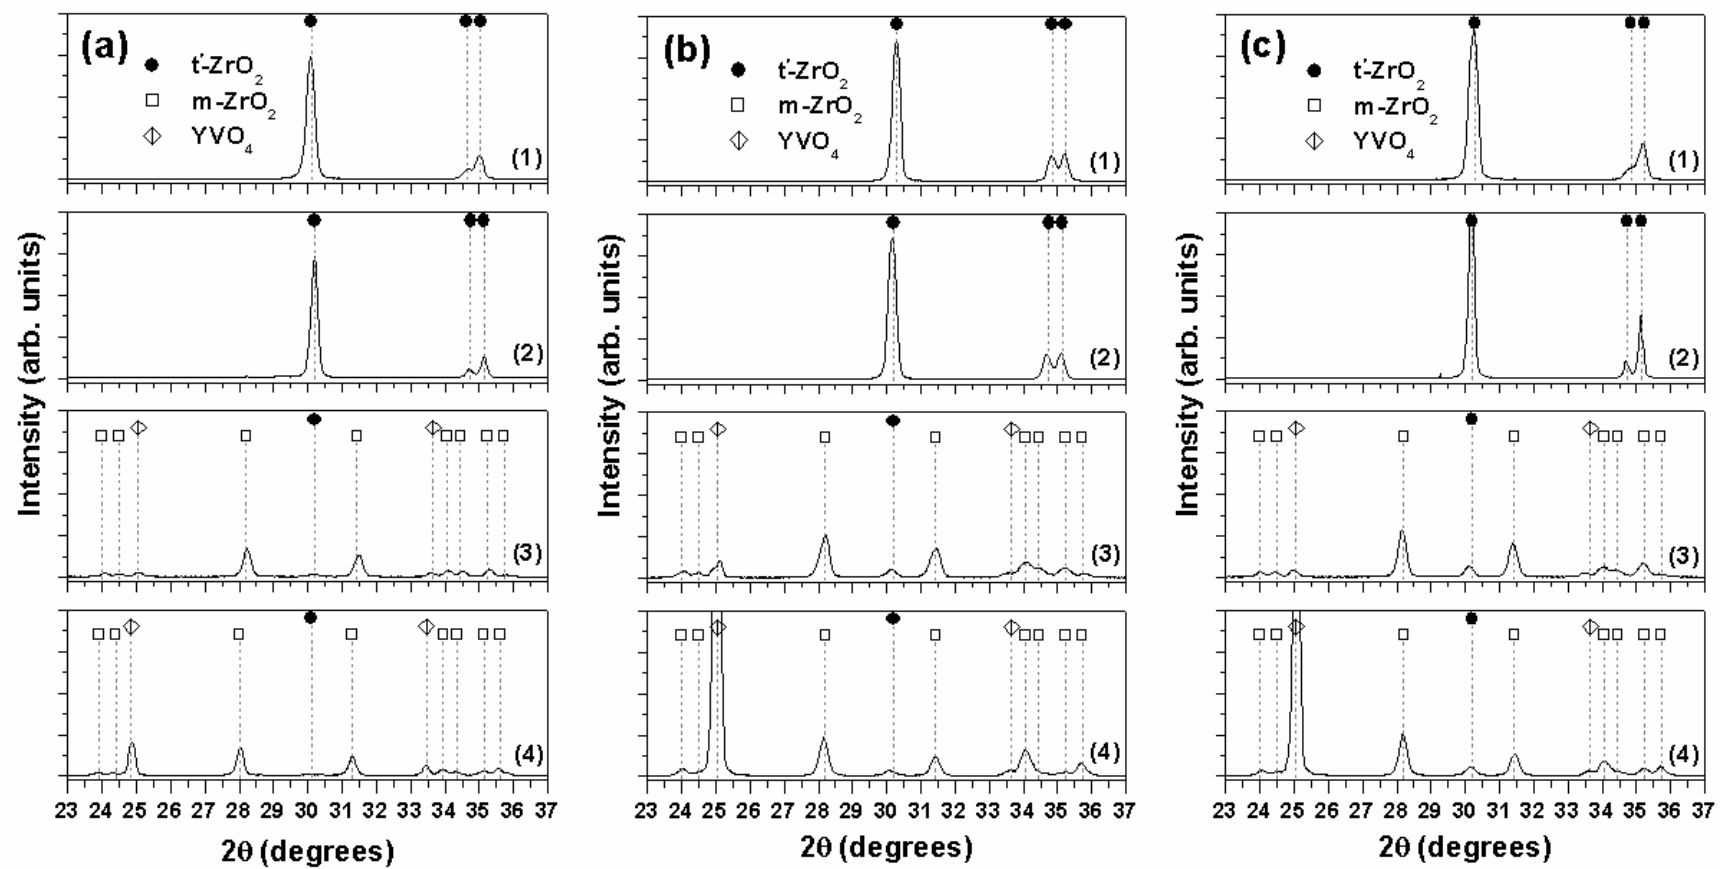
Fig. 4

Na₂SO₄ itself did not have significant consequences on destabilization of zirconia (2nd pattern of Fig. 4a,b,c). Only the one in the as-sprayed condition presented some traces of monoclinic phase (less than 2%, Fig. 5). The specimens corroded either by V₂O₅+Na₂SO₄ or V₂O₅ presented a high monoclinic/tetragonal peak intensity ratio indicating a destabilization of zirconia ranging from 87% to 97%. Moreover, the intensity of the main peak of YVO₄ is noticeably higher in specimens corroded by V₂O₅+Na₂SO₄ and is related with the formation of the large needle-like YVO₄ crystals (Fig. 2g,h,i).

Fig. 4. XRD spectra of coatings before and after the hot corrosion testing; (a) plasma-sprayed condition, (b) laser-glazed with CO₂ laser and (c) laser-glazed with Nd:YAG laser. (1) Before the corrosion testing; (2) tested with Na₂SO₄; (3) tested with V₂O₅ and (4) tested with V₂O₅+Na₂SO₄.

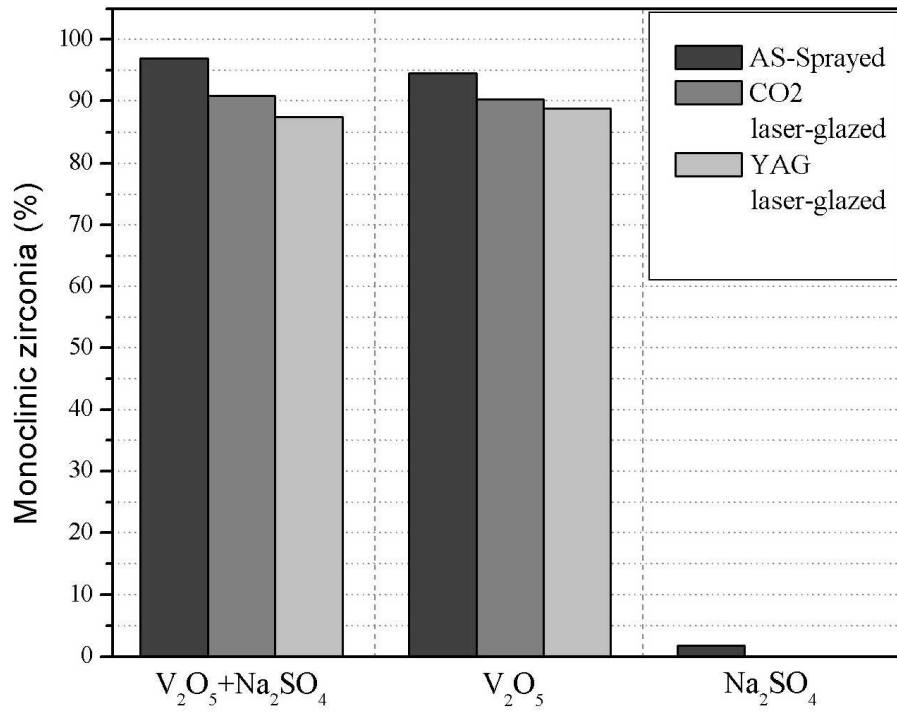
Fig. 5

A comparison of the destabilization fractions is presented in Fig. 5. It can be seen that V_2O_5 had a detrimental effect on the coatings leading to the transformation from tetragonal to monoclinic phase up to 97% in volume. The laser-glazed coatings reduced the destabilization at the surface although the effect was rather small (6-10%). They presented less monoclinic phase than the plasma-sprayed ones, being in agreement with the results obtained by Tsai and Hsu [13]. The Nd:YAG laser-glazed coatings presented lower destabilization than those glazed with the CO_2 laser as a result of a lower surface area due to absence of surface voids and smaller width of cracks (see Fig. 1b and c).

Fig. 5. Destabilization of zirconia coatings after the corrosion testing at 1000°C during 100 hours. Evaluation of the three sets of specimens: glazed with CO₂ laser, glazed with Nd:YAG laser and as-sprayed condition; tested with Na₂SO₄, V₂O₅ and V₂O₅+Na₂SO₄.

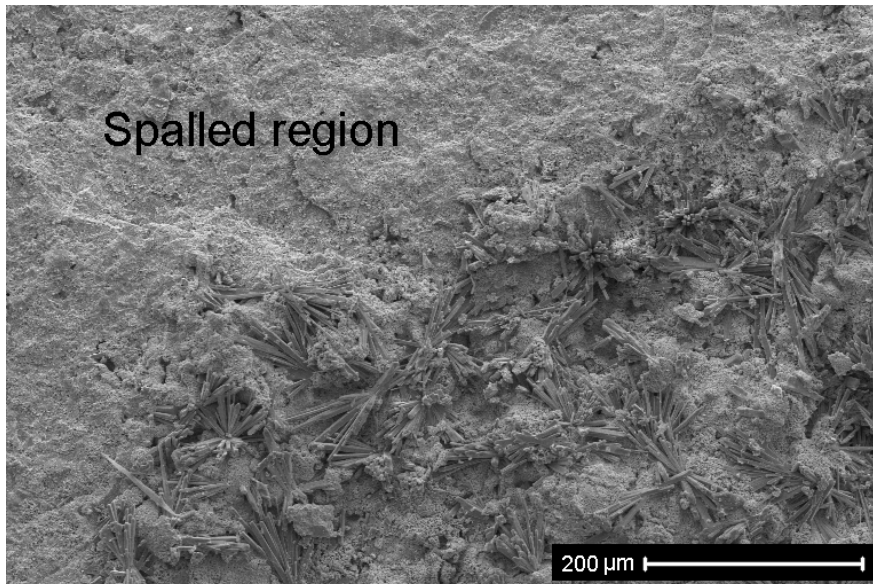
In Fig. 6 is shown the surface appearance of the coating Sprayed-MIX where a portion of the coating has spalled. The destabilization and consequent phase transformation to monoclinic accompanied with volume increase has severely weakened the coating. Furthermore, the formation of the needle-like YVO_4 crystals has introduced additional stresses to the damaged areas and hence contributed to the loss of material by spallation. On the other hand, the Sprayed- V_2O_5 coating failed not by losses of material from the outermost surface but by detachment from the bond coat due to phase transformation induced-stresses near the top coat/bond coat interface.

Fig. 6. View of the surface of Sprayed-MIX coating in a region where a large portion of material has spalled.

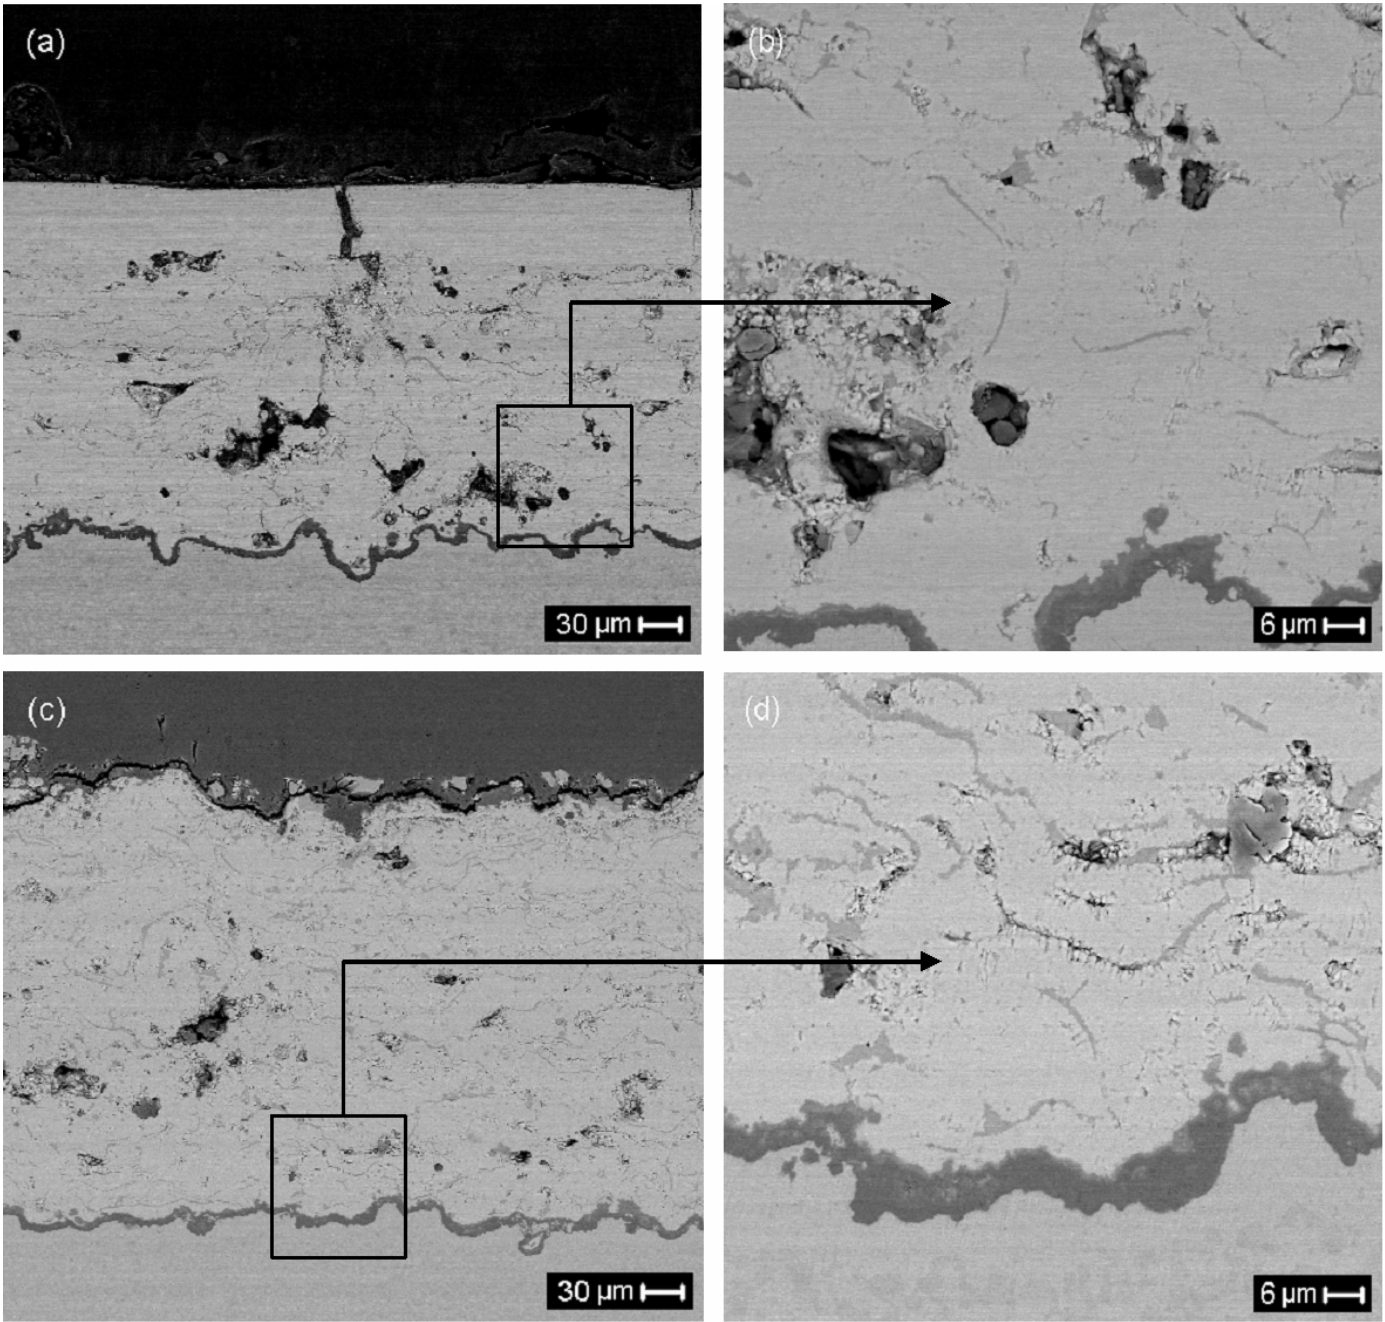
Fig. 7 shows backscattered-electron micrographs illustrating cross-sectional views of coatings CO_2 -MIX and Sprayed-MIX. It can be seen in Fig. 7b and d that in both cases pores and interlamellar gaps are filled with a compound chemically different from the zirconia matrix (slightly darker regions within the top coat) which was confirmed to be composed of yttrium, vanadium and oxygen by EDS analysis. The glazed layer has not been effective in avoiding molten salt infiltration due to the presence of surface cracks. The molten salts had deeply infiltrated through the whole thickness of the coatings reaching the top coat/thermally grown oxide (TGO) interface and reacted with yttria to form YVO_4 .

Fig. 7. Cross-sectional backscattered-electron micrographs of coatings (a) CO₂-MIX and (c) Sprayed-MIX; (b) and (d) are closer views from a region near the top coat/bond coat interface of the images on the left.

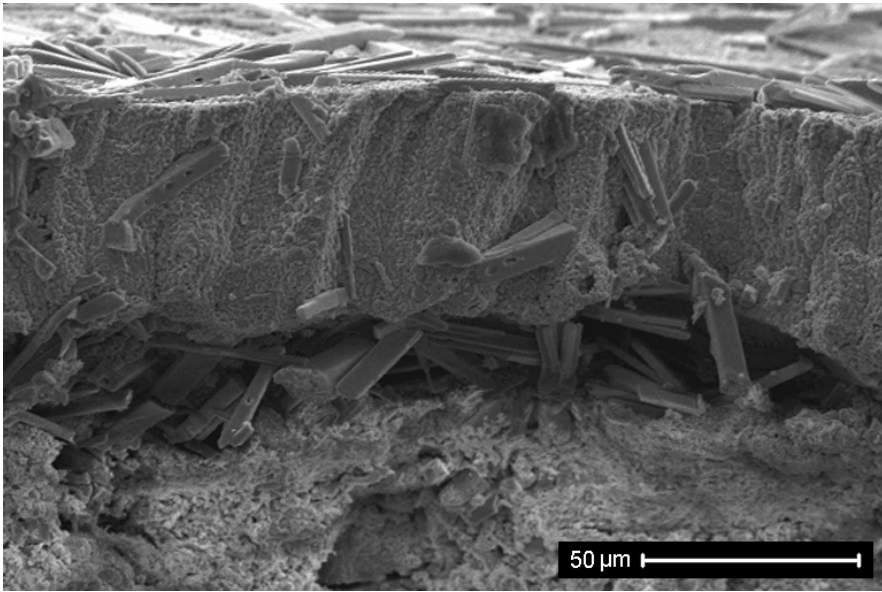
Fig. 8

A fracture surface of coating CO_2 -MIX after the corrosion testing is shown in Fig. 8. It is clearly visible a preferential formation of YVO_4 crystals just below the dense glazed layer where the contact area is much higher than that at the surface. The formation of those needle-like YVO_4 crystals may contribute to the failure of the coating not only by promoting the disruptive phase transformation from tetragonal to monoclinic but also by introducing additional stresses and thus reduce the tolerance of the TBC to thermal shock.

Fig. 8. Cross-sectional SE view of a fracture plane of coating CO₂-MIX after the corrosion testing. The laser glazed coating presented regions where the top glazed layer was detached from the plasma-sprayed microstructure.
