NRL/MR/6170--04-8763

Replacement of Chromium Electroplating on C-2, E-2, P-3 and C-130 Propeller Hub Components Using HVOF Thermal Spray Coatings

March 31, 2004

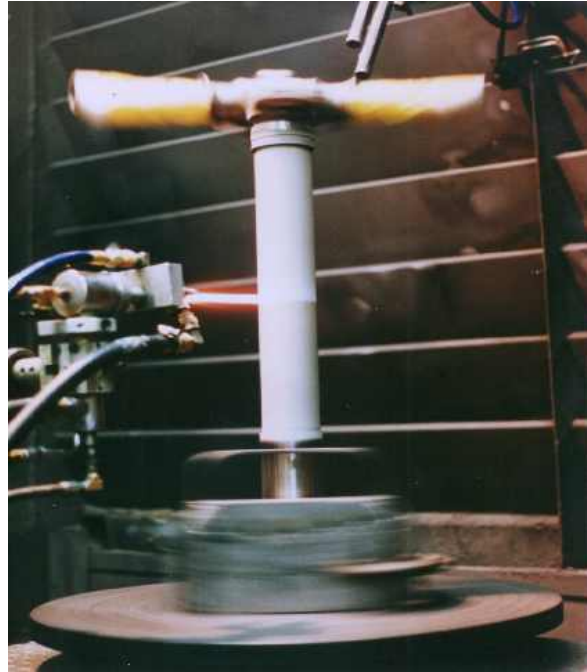
Figure 2-2. HVOF Spray of Landing Gear Inner Cylinder

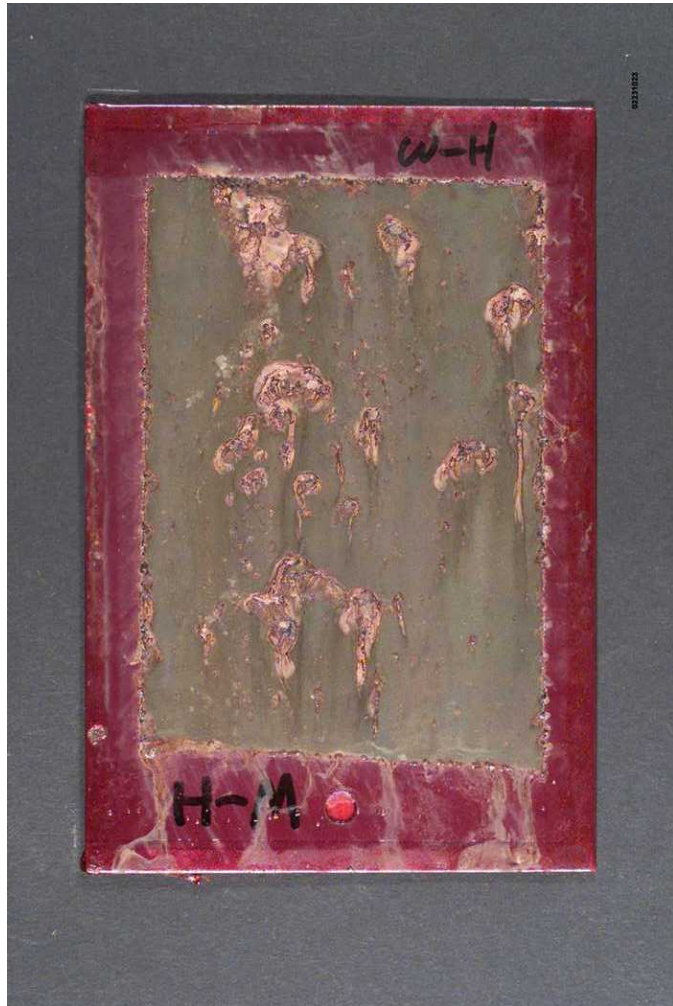
Figure 3-2. 0.001"-Thick WC/Co HVOF

The WC/Co and WC/CoCr corroded in one or two specific locations rather than many locations. Due to the very dense nature of the coatings, the coating must fail from a few random flaws in the coating rather than evenly dispersed porosity. The source of these flaws was therefore important. If they were generated due to the warping of the panel, it is possible that better corrosion resistance could be expected on actual components that can resist warping.

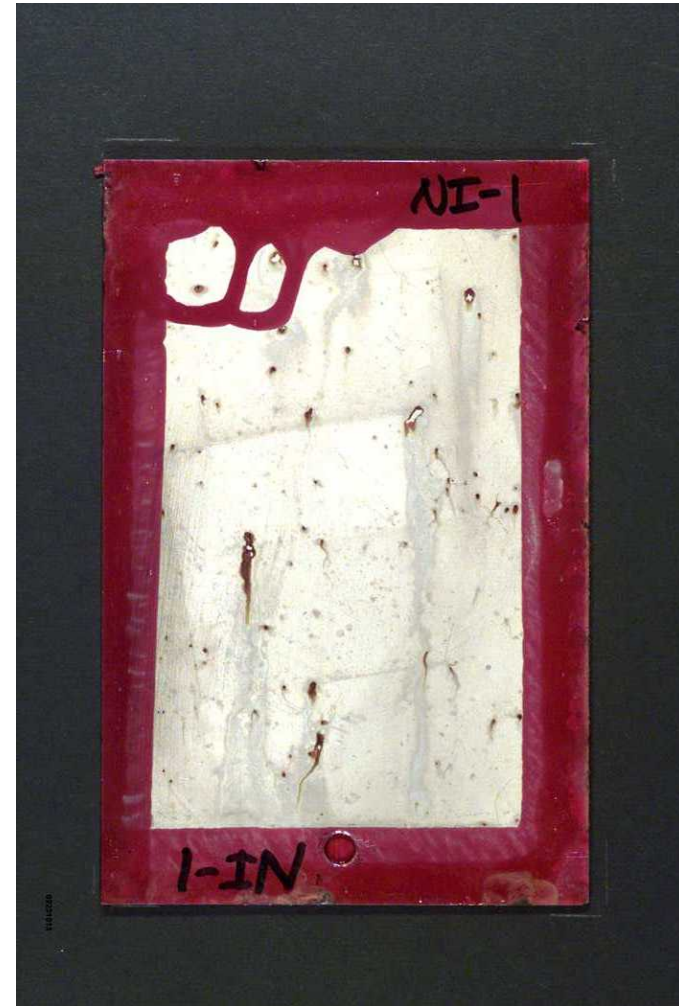
Figure 3-3. 0.001"-Thick Nickel Plate

The nickel plate applied to the panel was soft nickel with a resulting tensile residual stress rather than a hard nickel with a compressive residual stress. This was due to miscommunications within the plating facility. While this condition would be less than optimum for wear testing, we believe it had a negligible impact on the outcome of the corrosion tests. In our opinion, the state of coating residual stress had little effect on the barrier protection provided by the nickel.

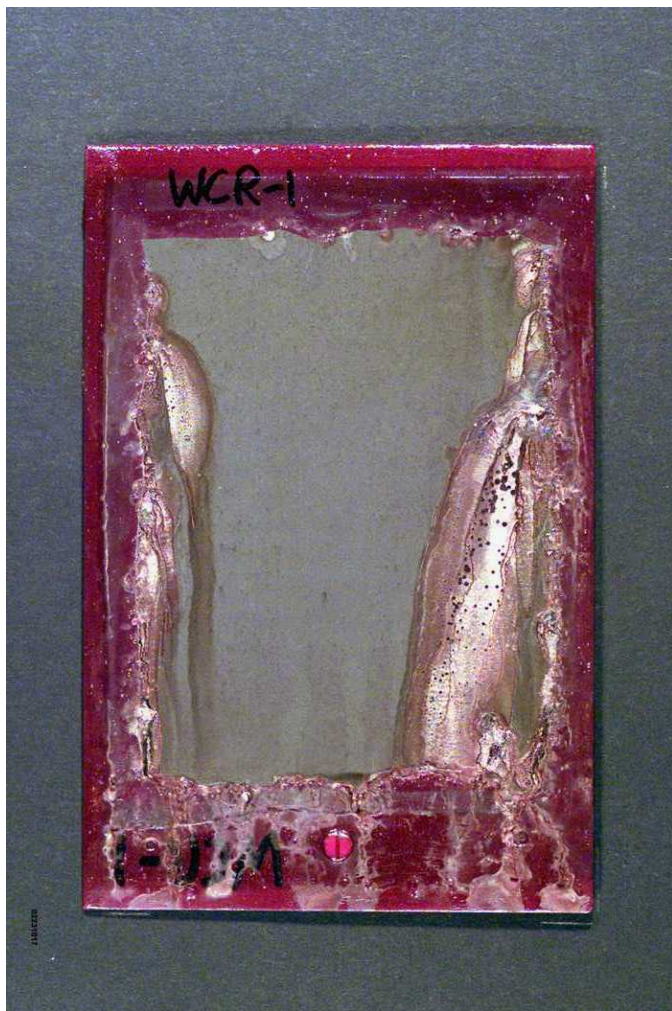
Figure 3-5. 0.001"-Thick WC/CoCr HVOF

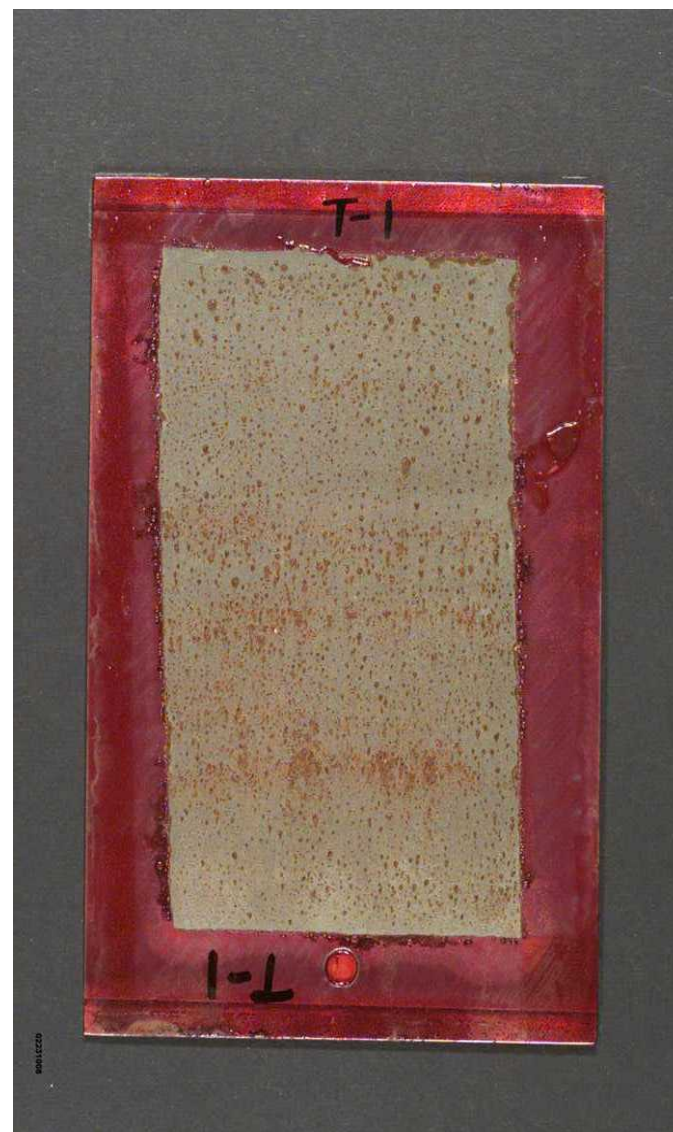
Figure 3-4. 0.001"-Thick Tribaloy T-800 HVOF

The Tribaloy coating tended to “bleed” rust from many different areas dispersed over the coating surface. This is due to the higher porosity level in the Tribaloy allowing multiple paths for corrosives to reach the substrate.

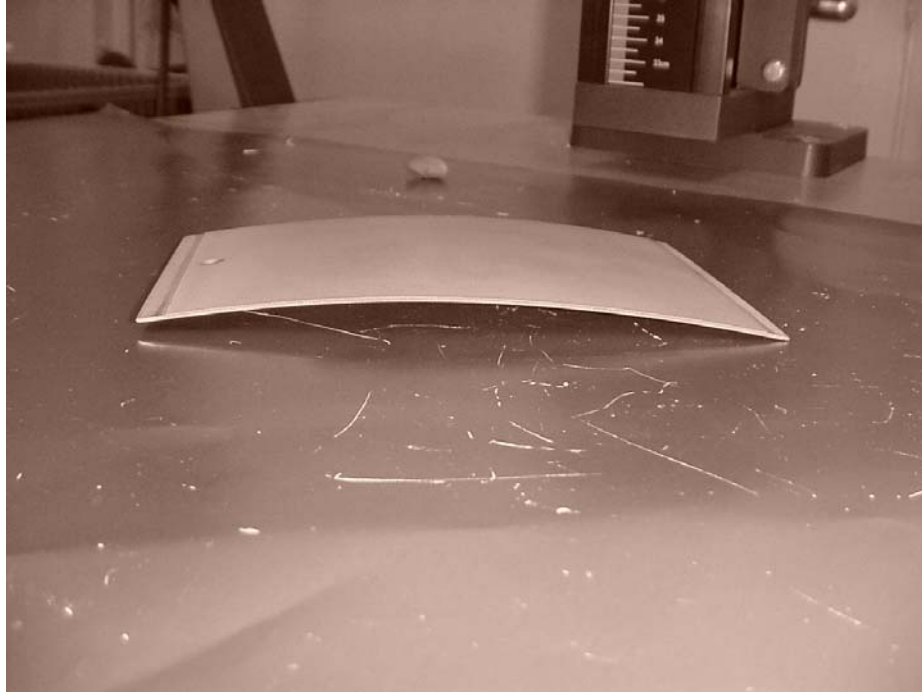
Figure 3-6. WC/Co Coated Panel, Top Surface Coated

The high compressive stresses in the HVOF coatings caused the panels to warp substantially, as shown in Figure 3-6. To overcome this effect and restore flatness for grinding, the reverse sides of the panels were glass-bead-peened. The as-coated (not machined) panels were not peened. Even after peening, some panels still bowed slightly in the opposite direction, see Figure 3-7. To prevent uneven grinding, which would result in a non-uniform coating thickness, the edges of the panels were clamped to the table of the surface grinder to allow the middle of the panel to be machined. This setup was also required for the nickel-plated panels, which had bowed in tension creating a slightly concave surface.

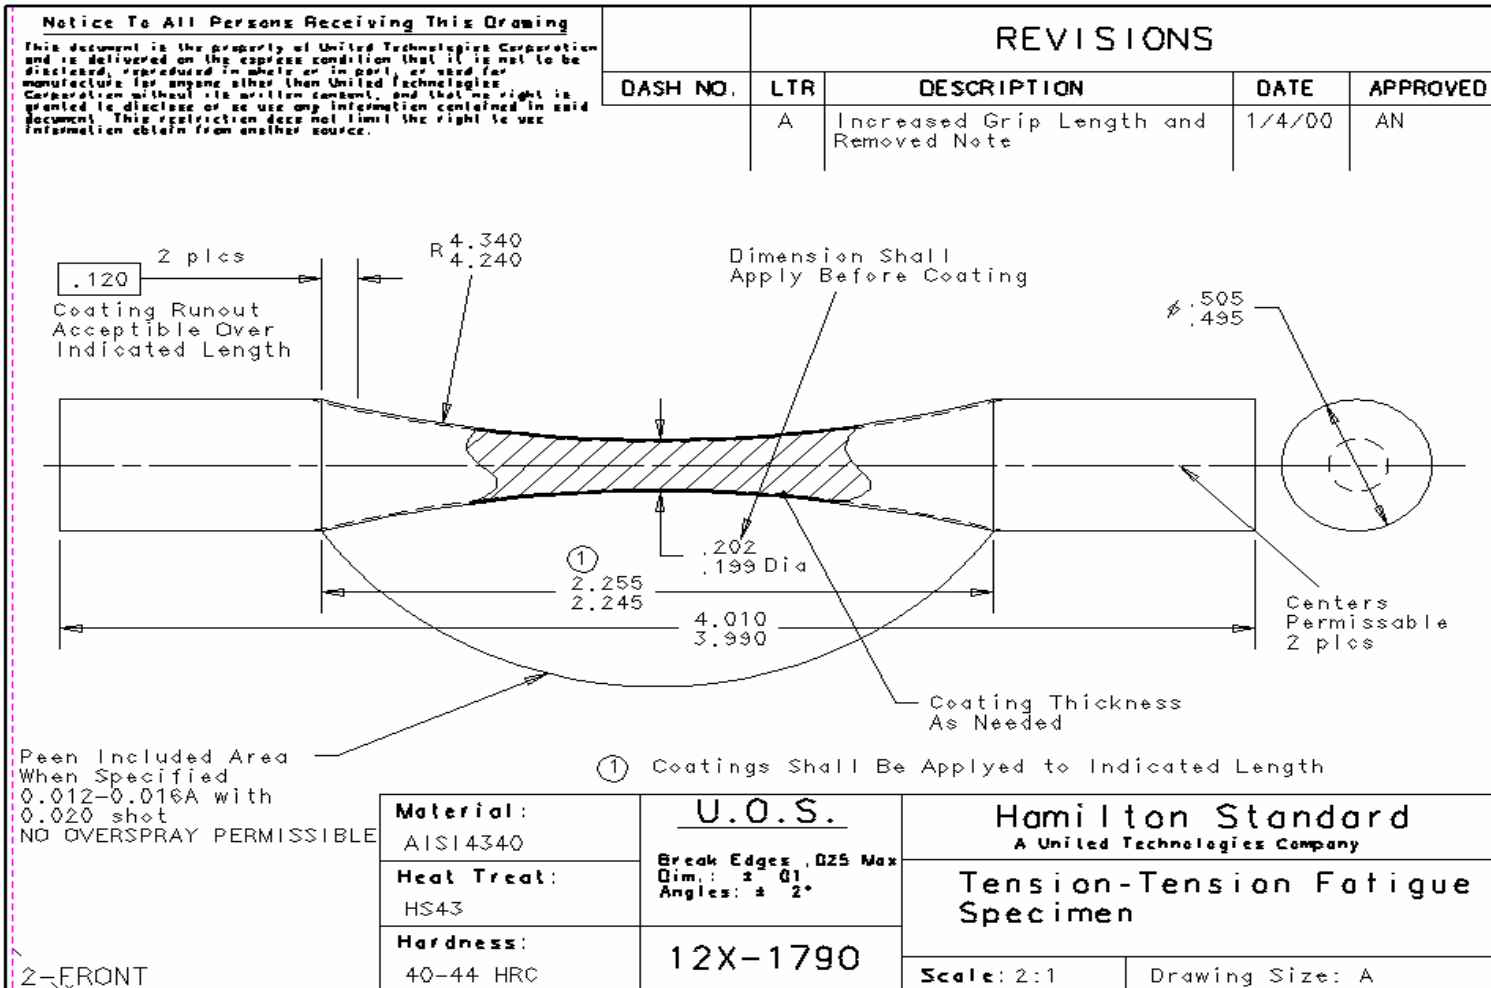
Figure 3-8. Tension/Tension Fatigue Specimen - Smooth

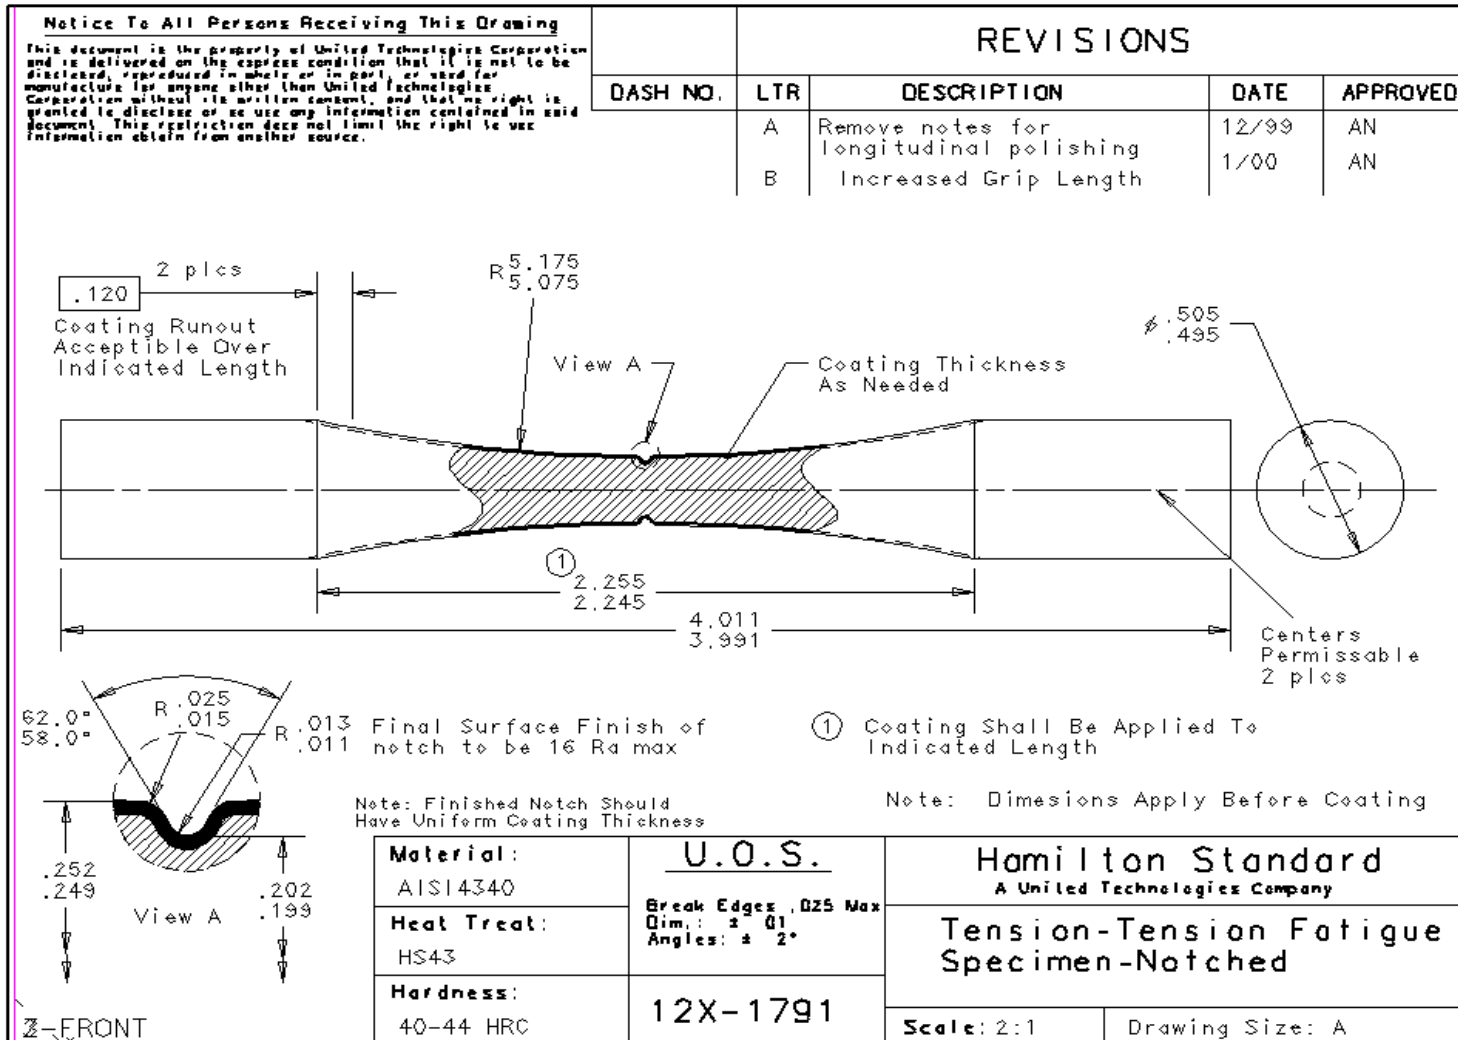
Figure 3-9. Tension/Tension Fatigue Specimen – Notched

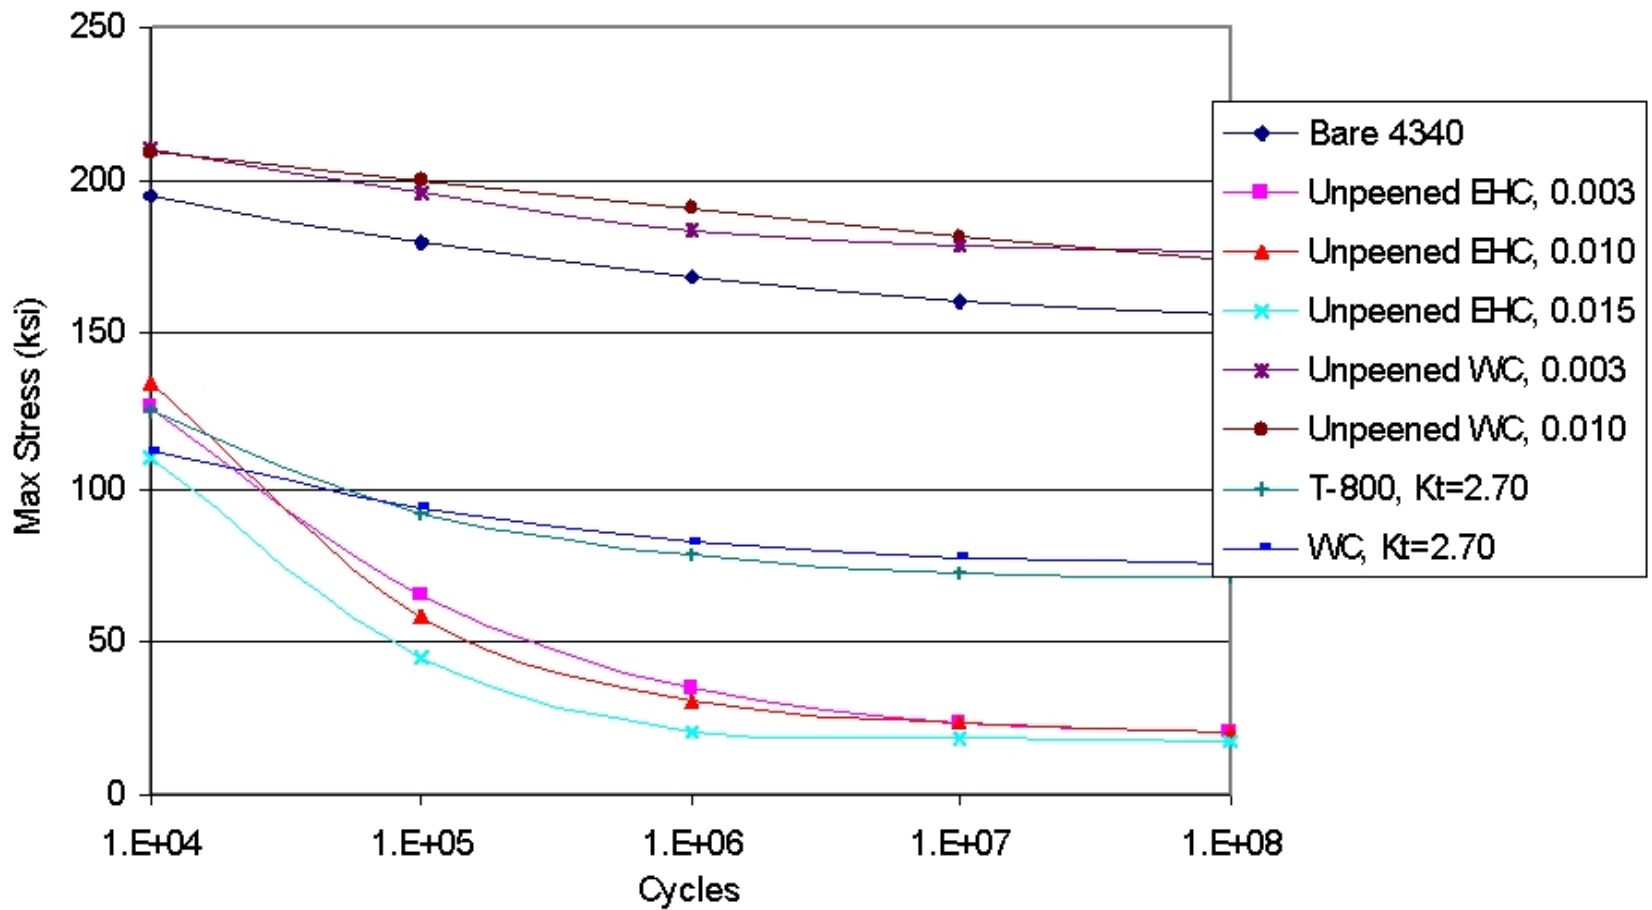
Figure 3-11. S/N Curves for Non-Peened Coatings and Notched Specimens

The WC/17Co was found to have higher fatigue notch sensitivity than the T-800. However the actual strength levels in the presence of a notch were equivalent.

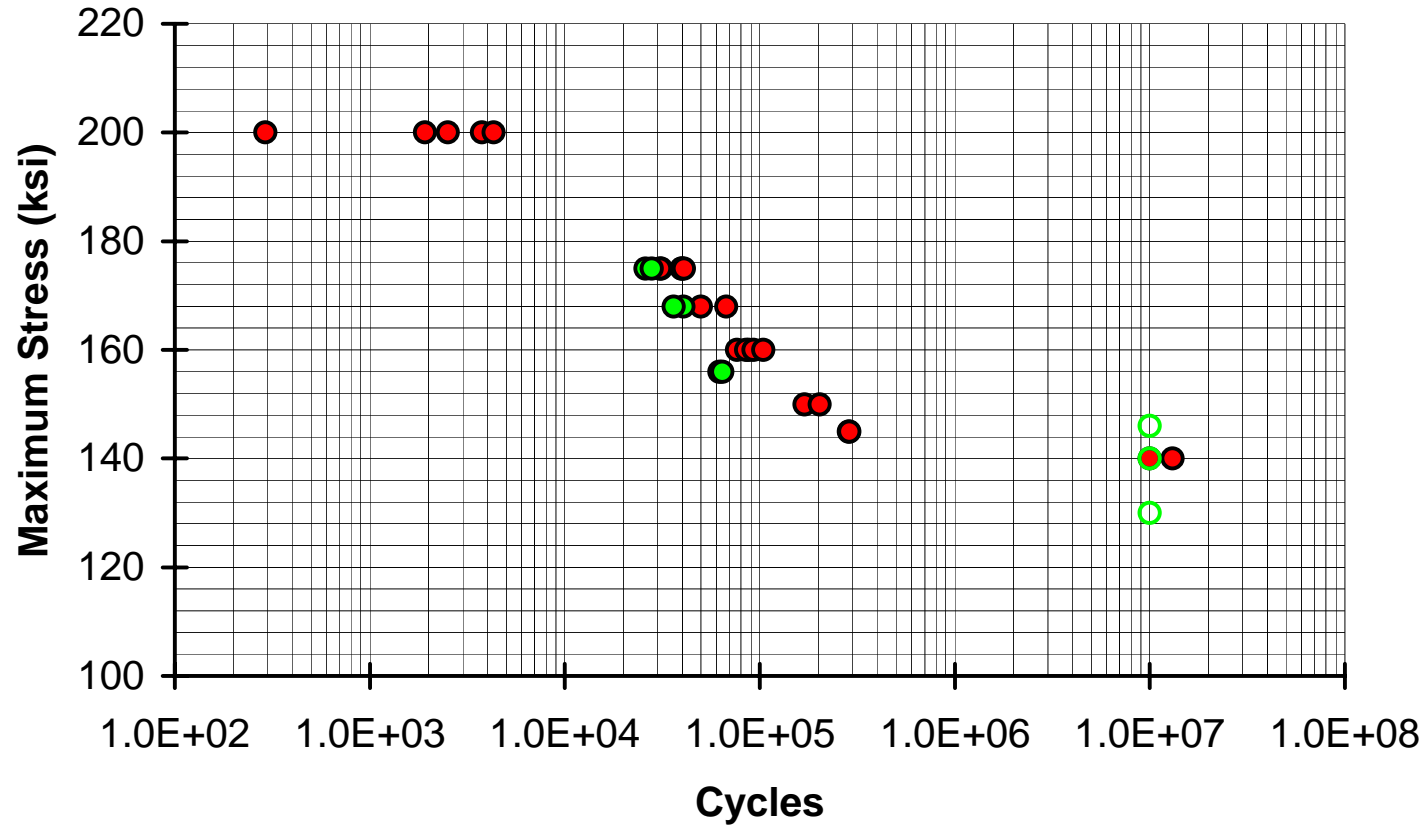
AISI 4340, HRC 40-44, R=0.1, .003" T-800

Red Points - Peened

Open Circles Denoting Runouts

Figure 3-12. S/N Curves for 0.003" T-800 on 4340 Steel, R = 0.1

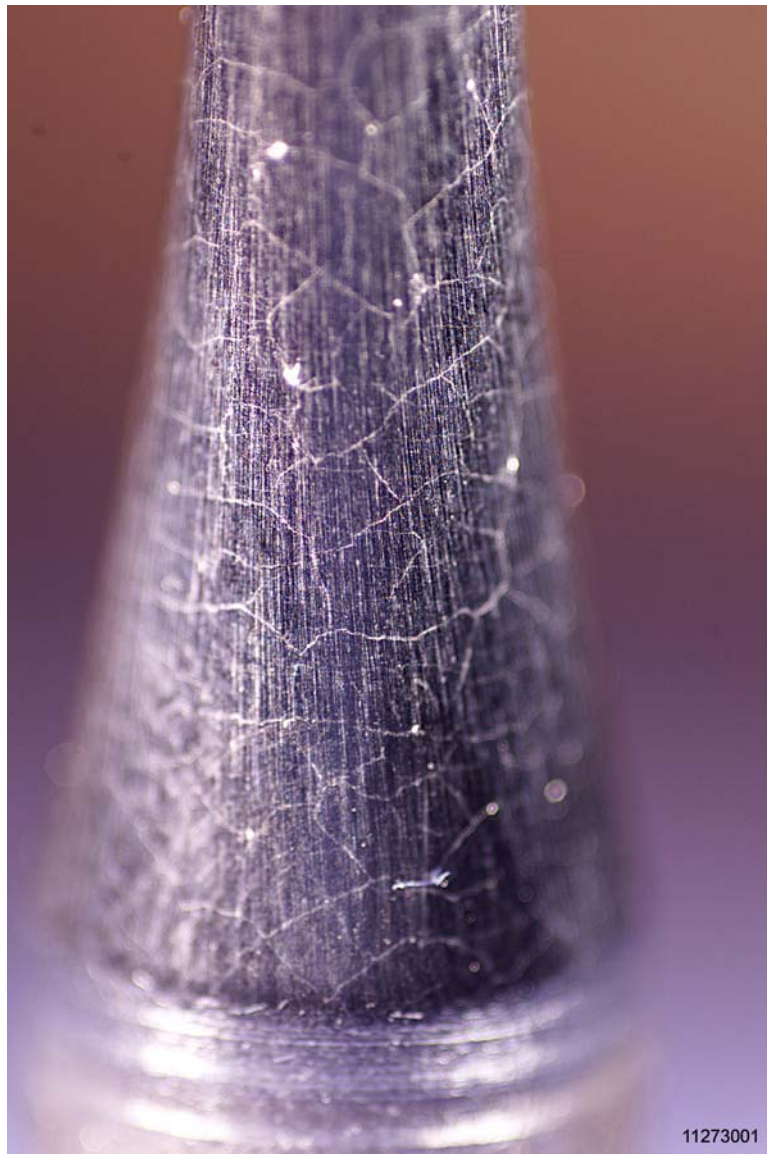
Figure 3-15. White Light of EHC Coated Specimen Showing Cracks Created By Machining Process

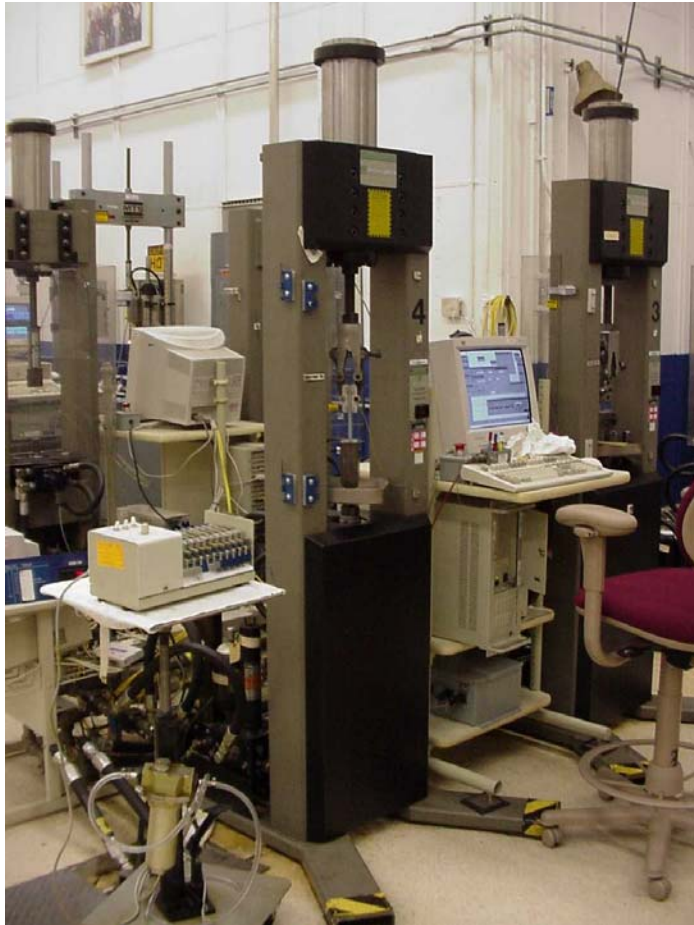
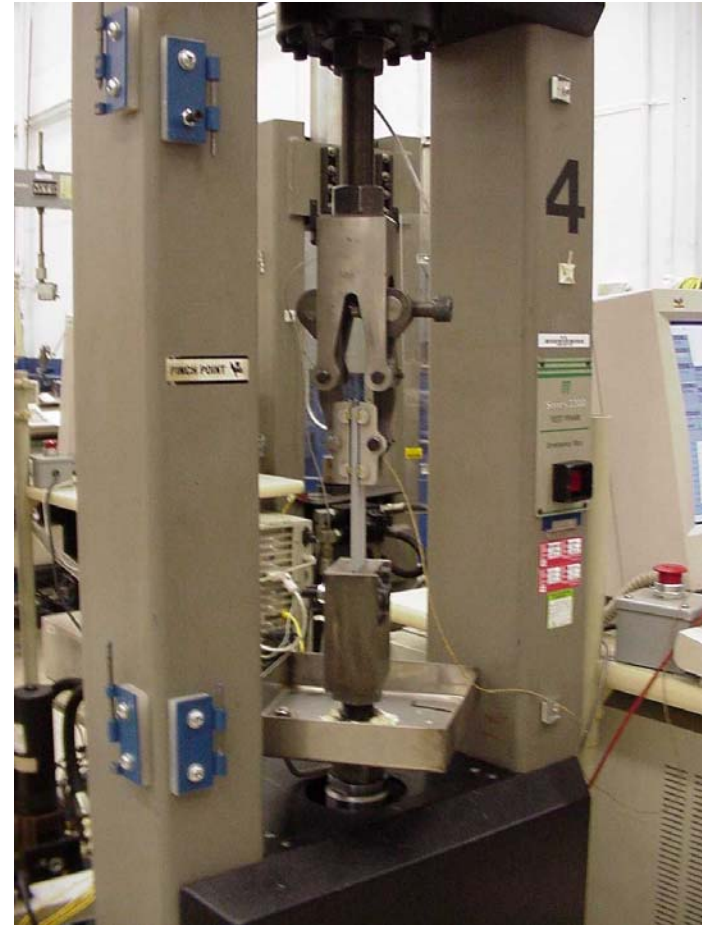
22,000 pound servo-hydraulic fatigue test frame

Test fixture including oil drip pan

Figure 3-19. Wear Test Fixture in Test Frame

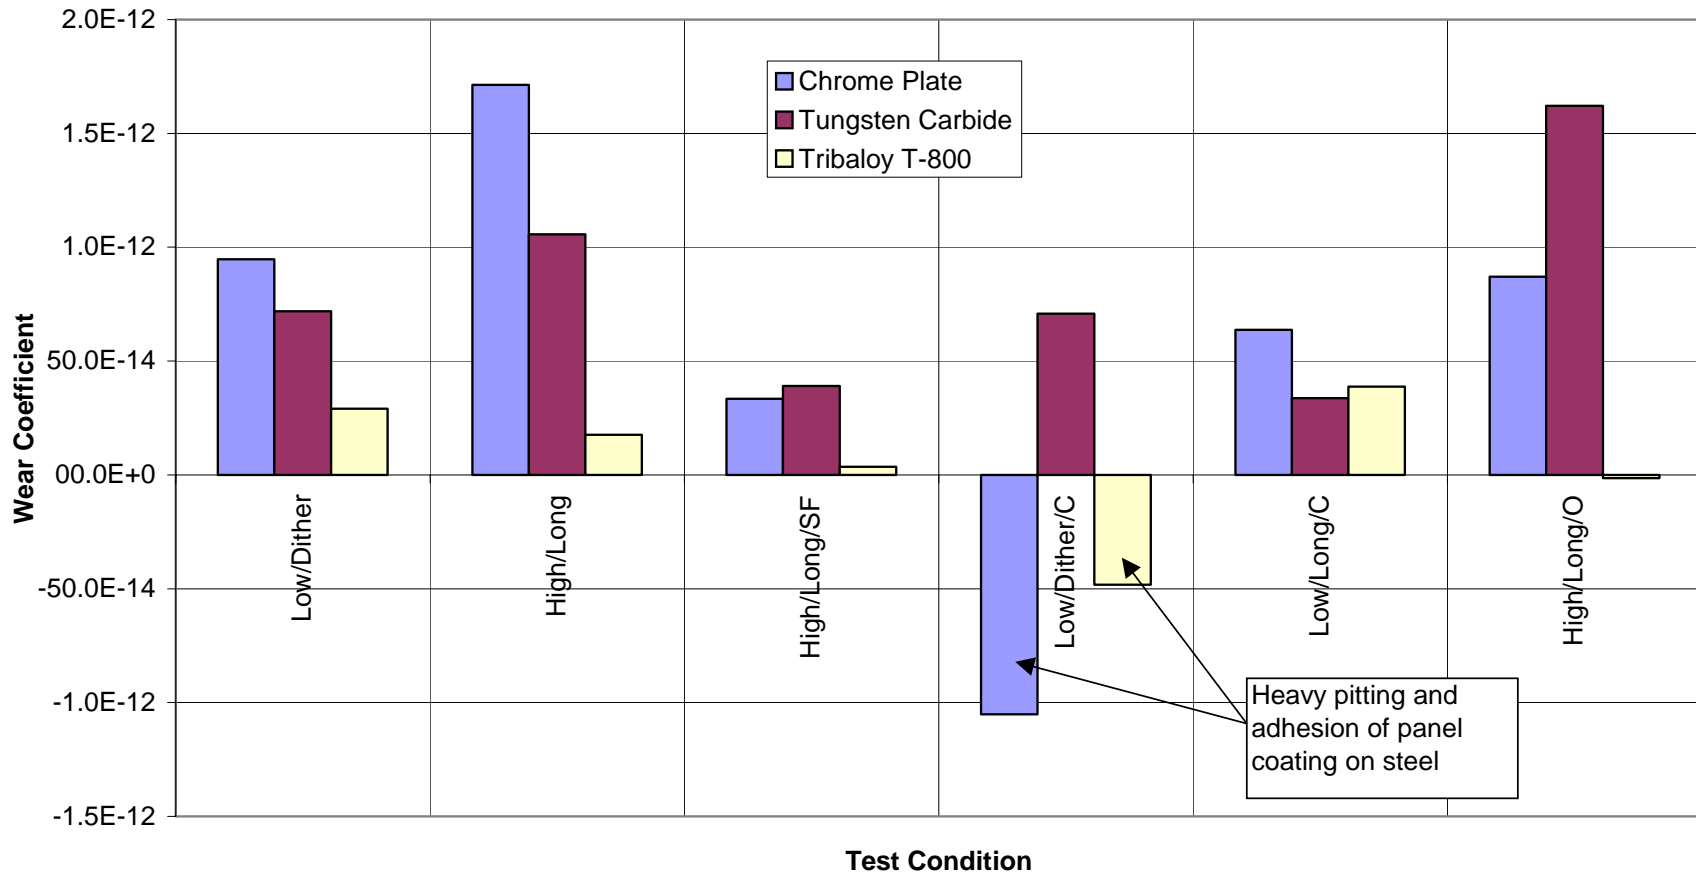
Steel Wear Rate Comparison Based on Mass Loss Measurements

Figure 3-21. Steel Wear Rate Comparison

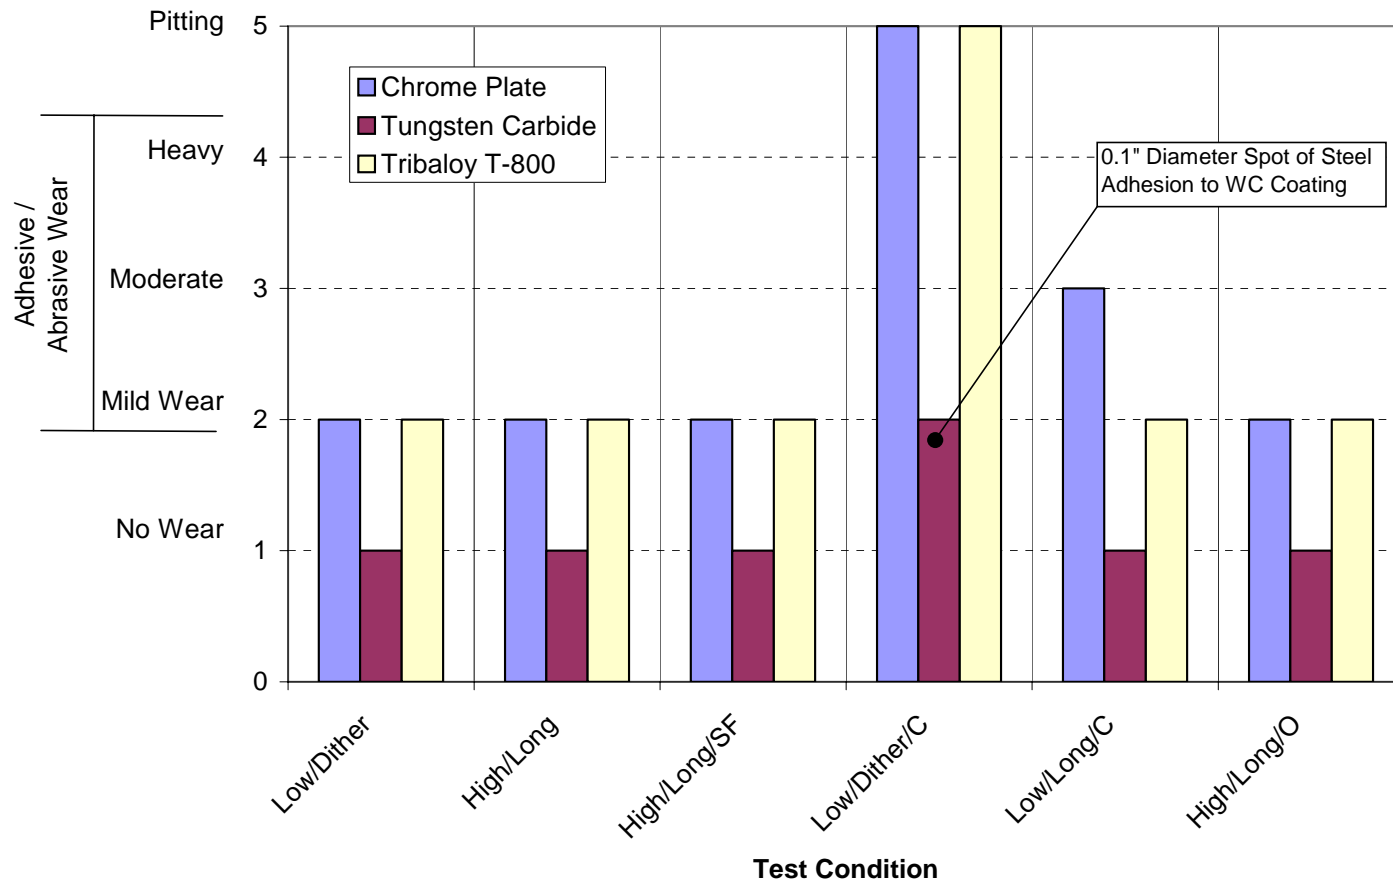
Panel Wear from Steel Specimens

Figure 3-22. Panel Wear From Steel Specimens

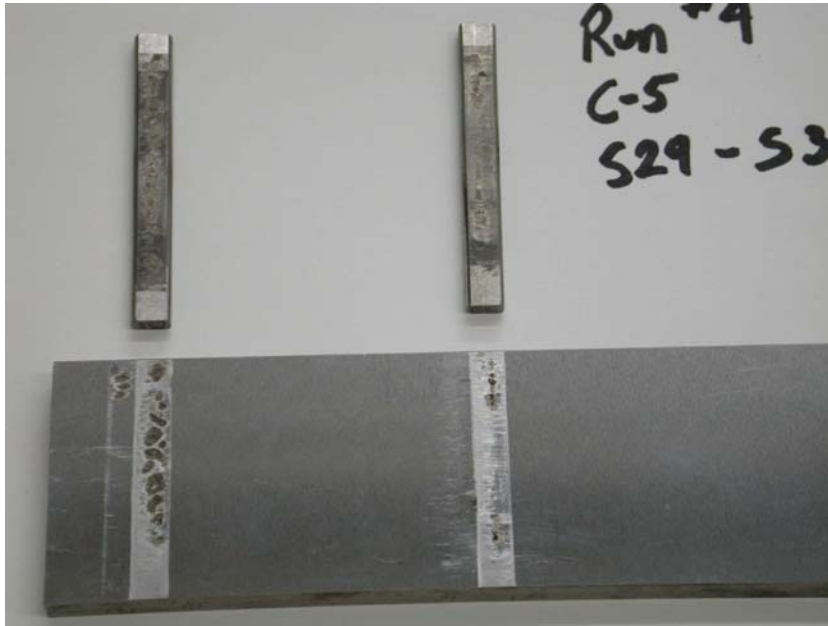
Figure 3-23. EHC Dithering in Contaminated Oil With Steel Counter-faces

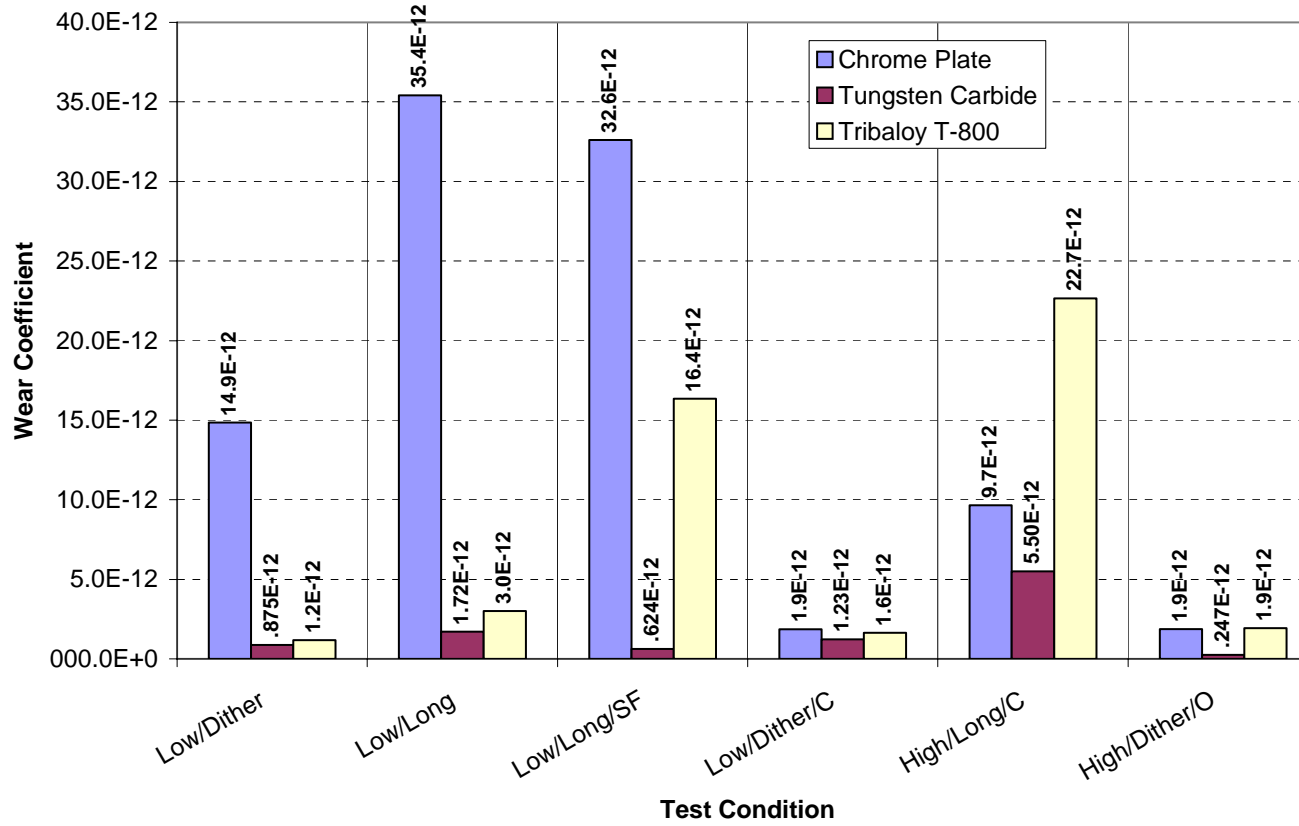
Copper Wear Rate Comparison Based on Mass Loss Measurements

Figure 3-26. Copper Wear Rate Comparison

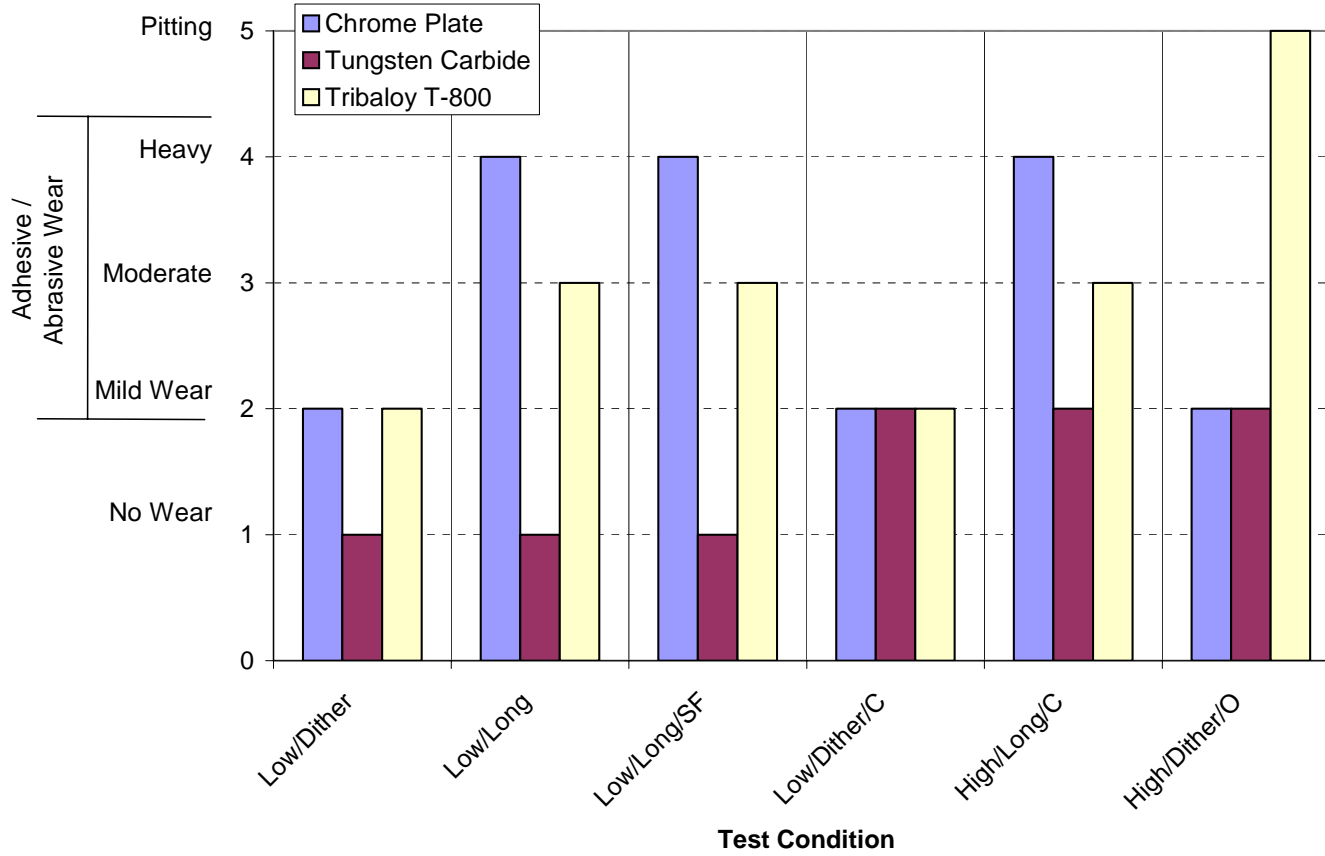
Panel Wear from Copper Specimens

Figure 3-27. Panel Wear From Copper Specimens

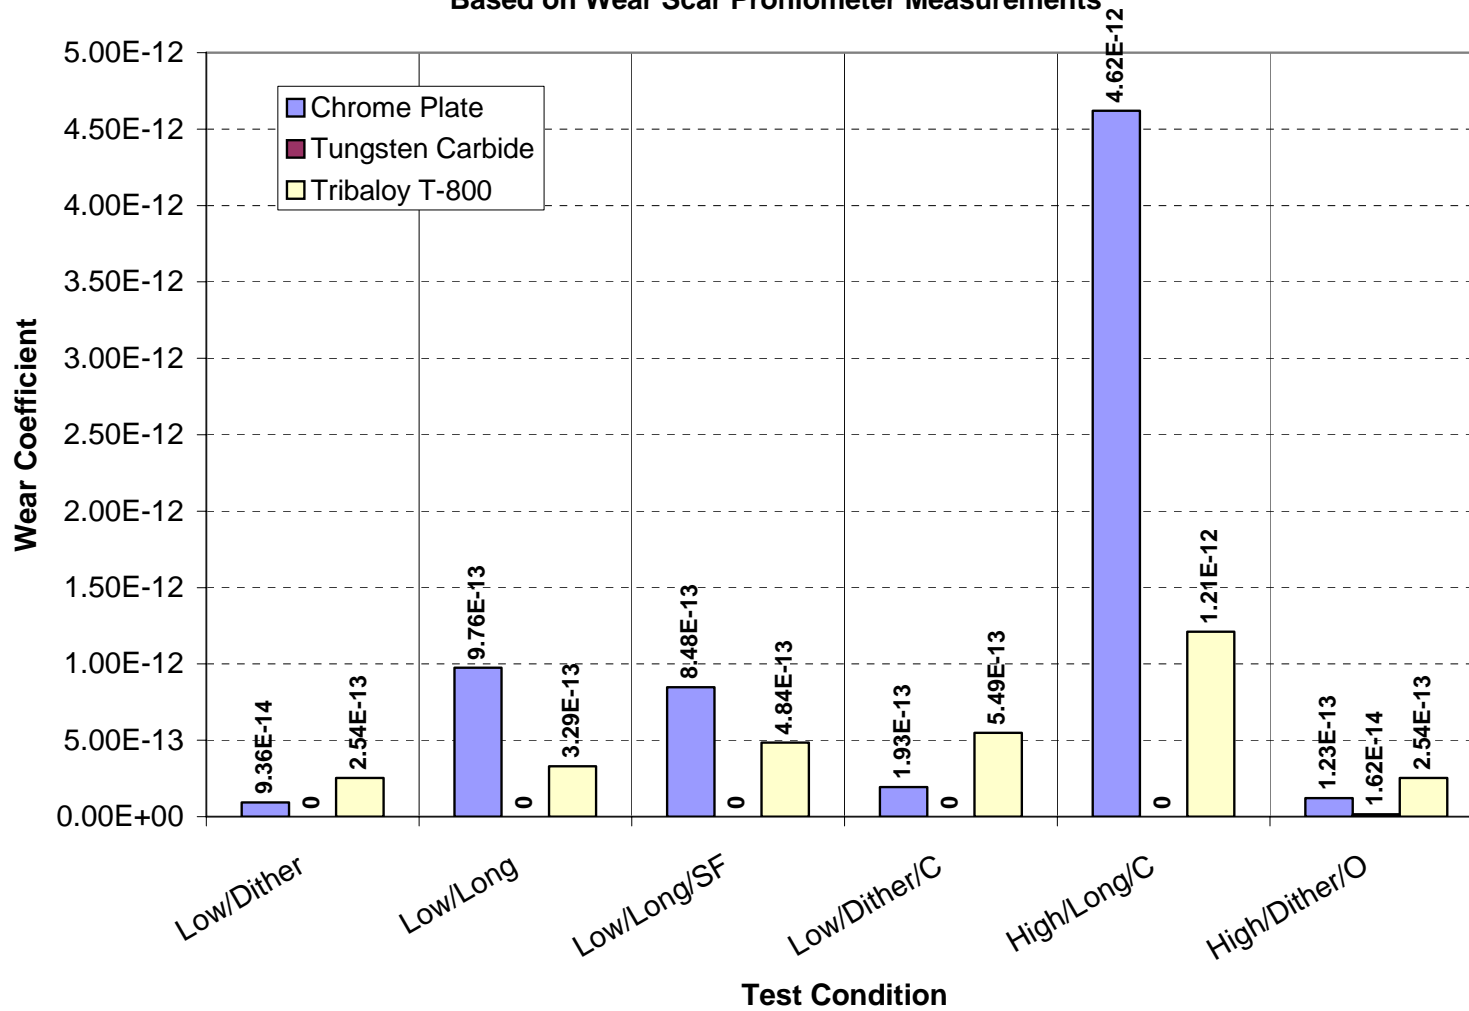
Panel Wear Rate Coefficient Against Copper Counterfaces Based on Wear Scar Profilometer Measurements

Figure 3-28. Panel Wear Rate Coefficient Against Copper Counter-Faces

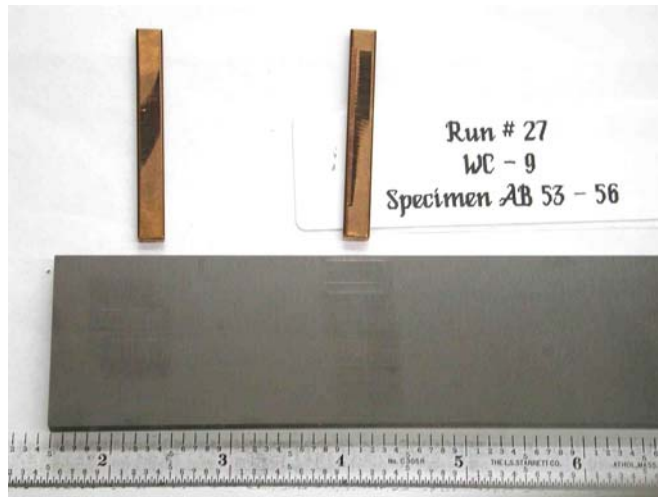
Figure 3-30. WC/Co Reciprocating Against Copper Counter-Faces

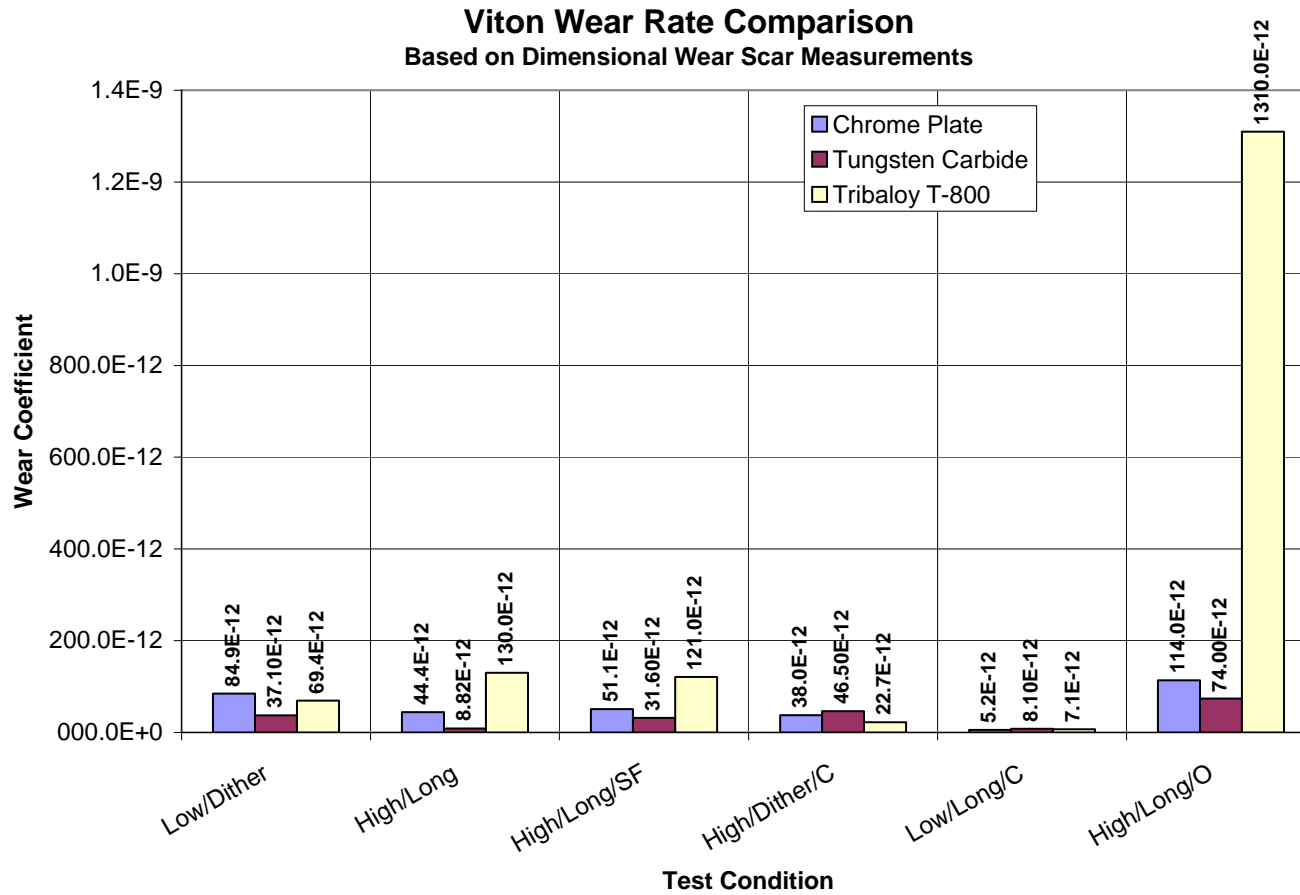
Figure 3-32. Viton Wear Rate Comparison

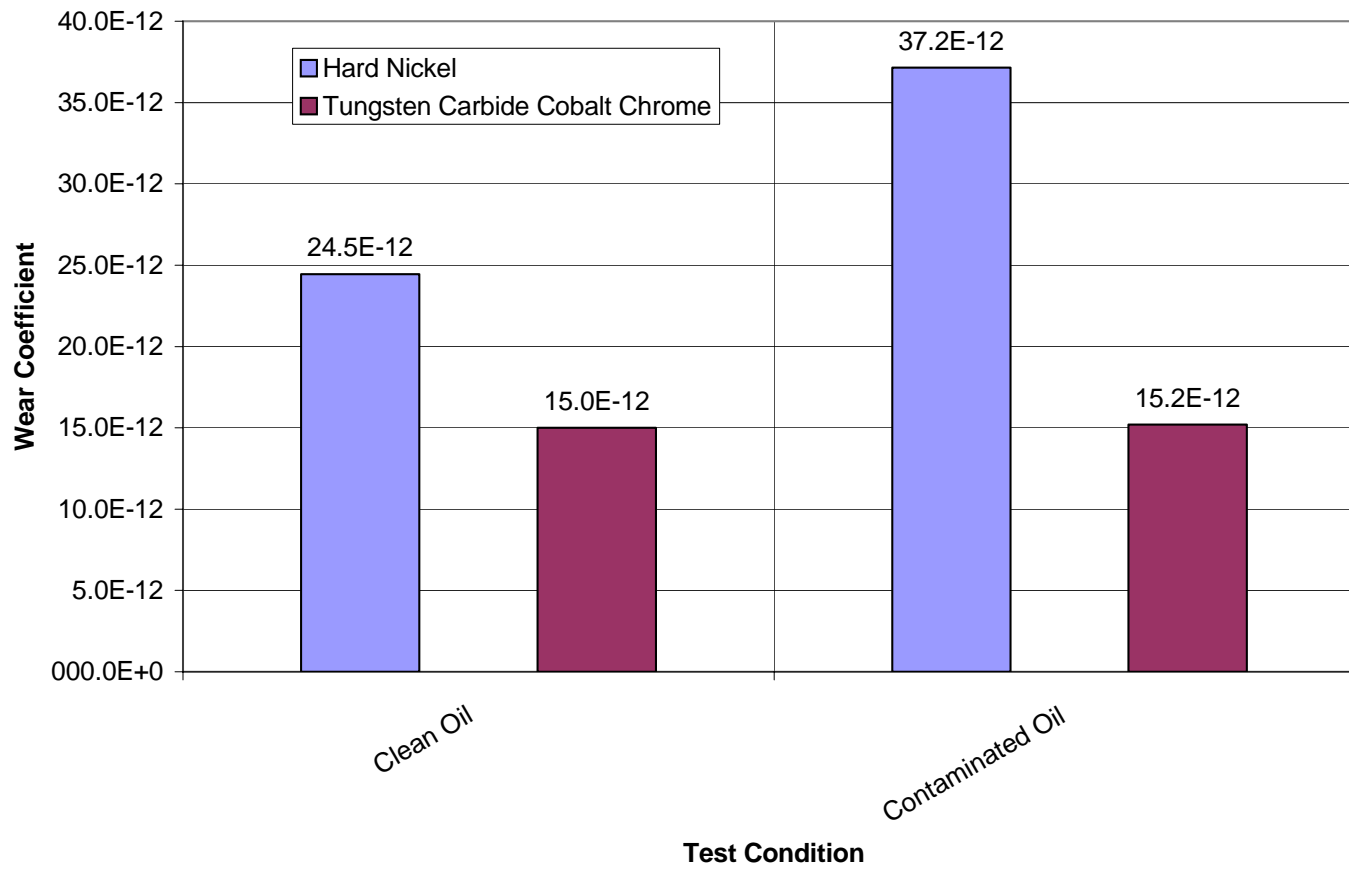
PTFE Wear Rate Comparison Based on Mass Loss Measurements

Figure 3-34. PTFE Wear Rate Comparison
