NRL/MR/6170--04-8763

Replacement of Chromium Electroplating on C-2, E-2, P-3 and C-130 Propeller Hub Components Using HVOF Thermal Spray Coatings

March 31, 2004

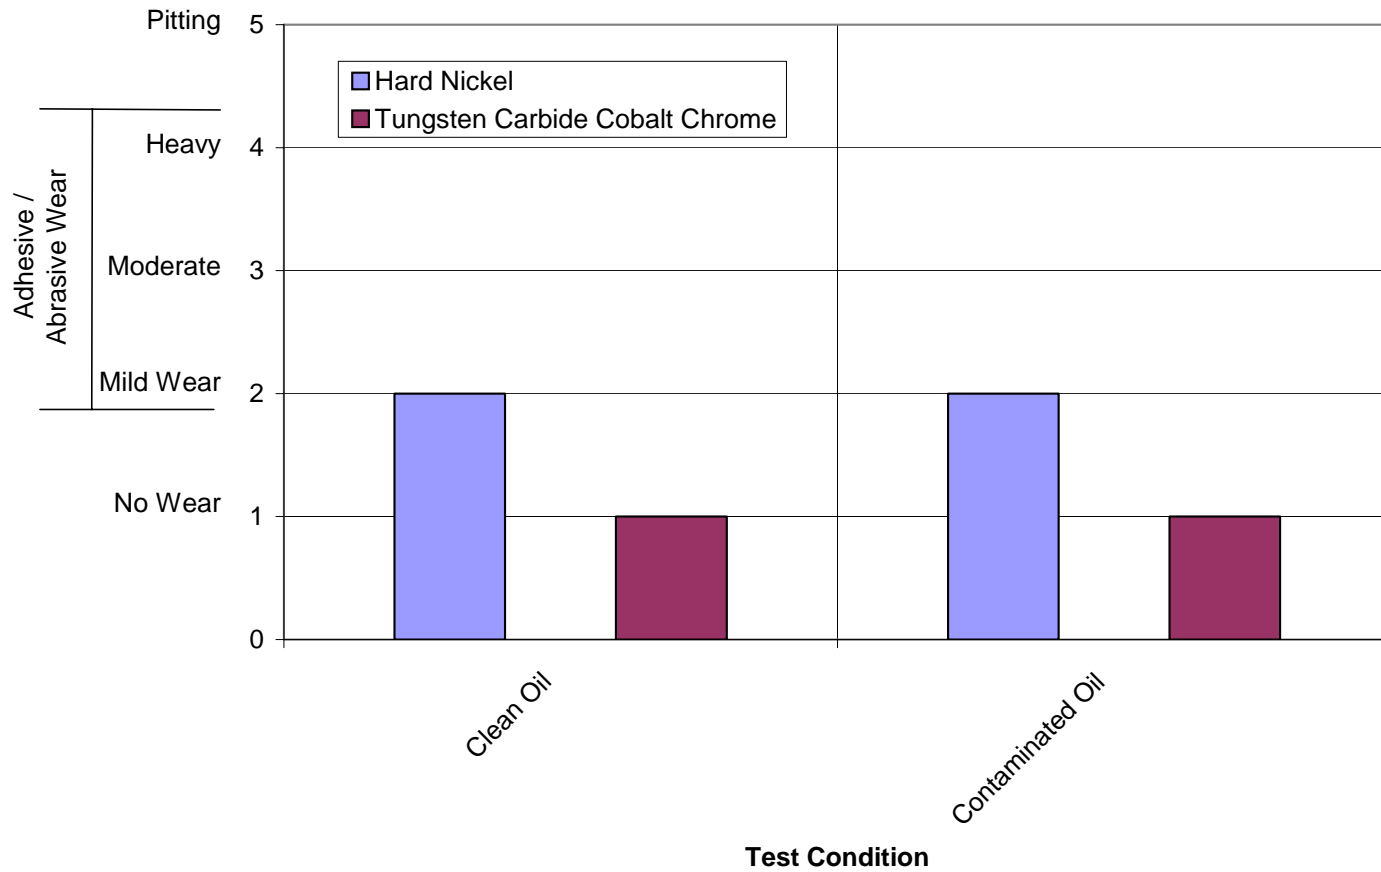
Panel Wear from PTFE Specimens

Figure 3-35. Panel Wear From PTFE Specimens

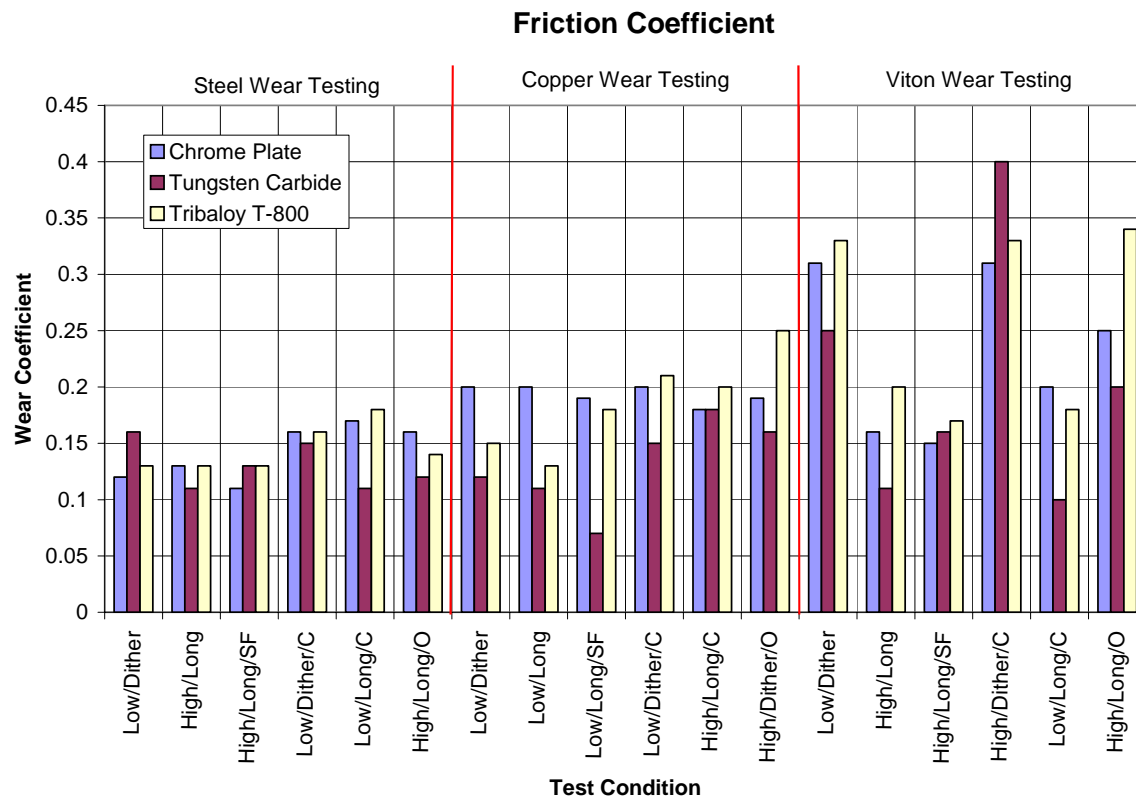
Figure 3-38. Friction Coefficients

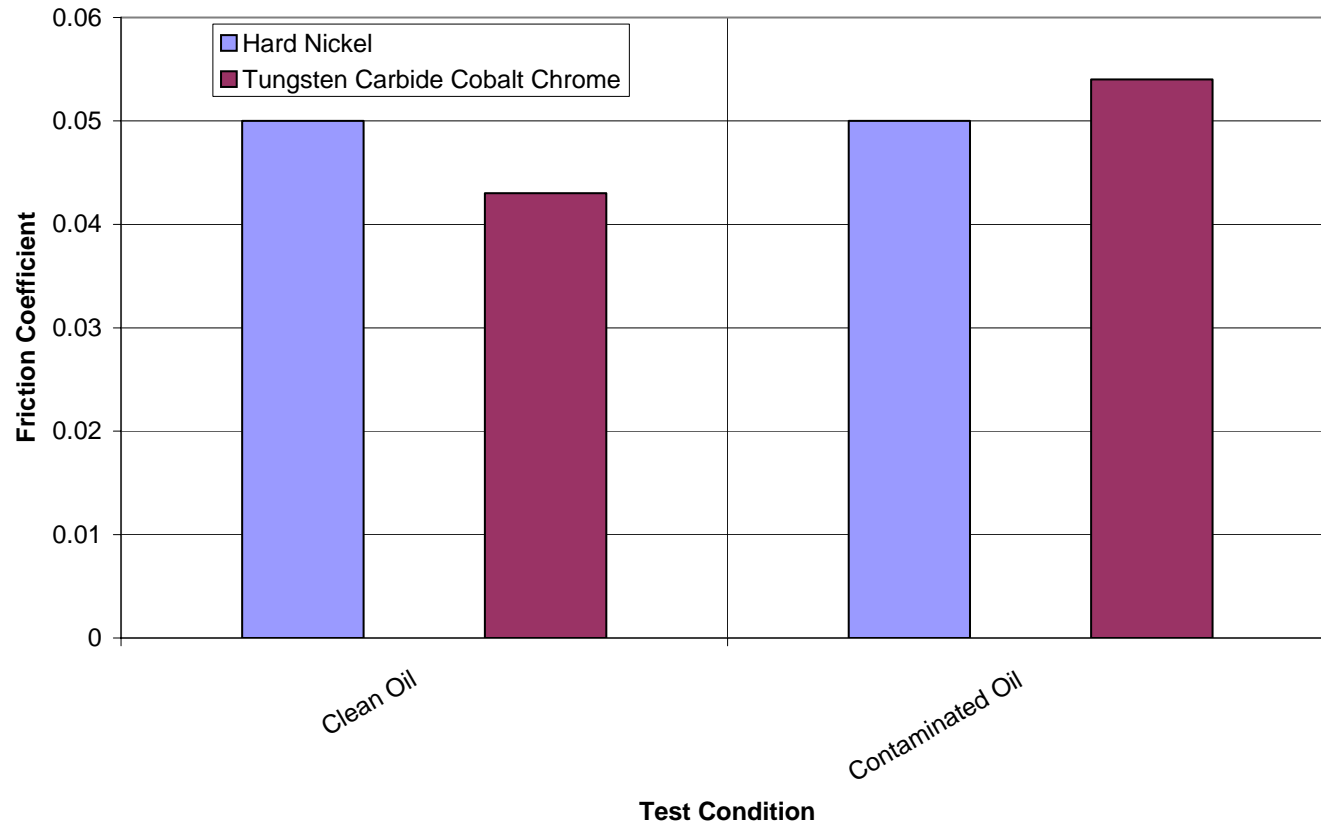
PTFE Friction Coefficient Comparison

Figure 3-39. PTFE Friction Coefficient Comparison

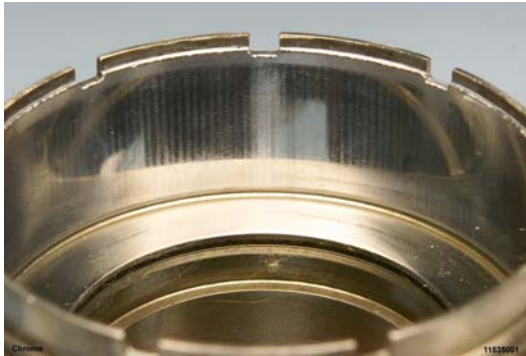
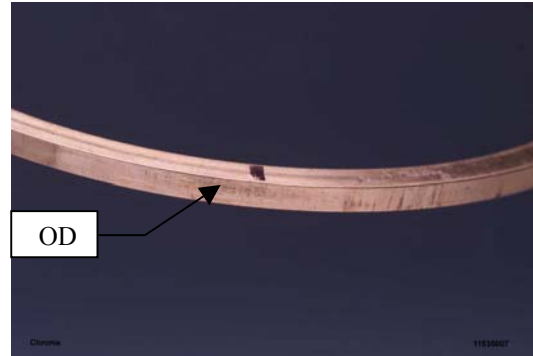
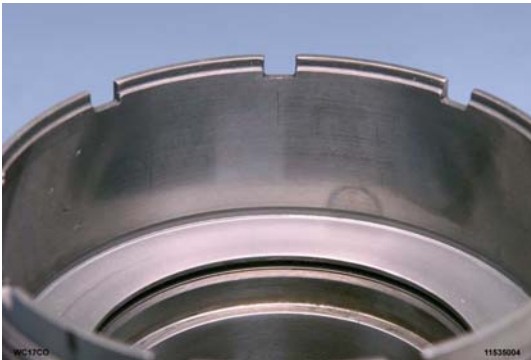
Chrome Sleeve

Piston Ring from Chrome Sleeve

WC-17Co Sleeve

Piston Ring from WC-17Co

Figure 3-50. Low-Pitch-Stop Sleeves and Piston Rings After Testing

Based on the test results, Hamilton Sundstrand recommends WC/17Co as a replacement for chrome plate on the ID of the low pitch stop lever sleeve for the 54460 and 54H60 applications. Wear of the HVOF coating in a simulated operating environment was less than the baseline chrome. The HVOF-coated bore produced less wear on the mating piston ring than did the chrome-plated bore.

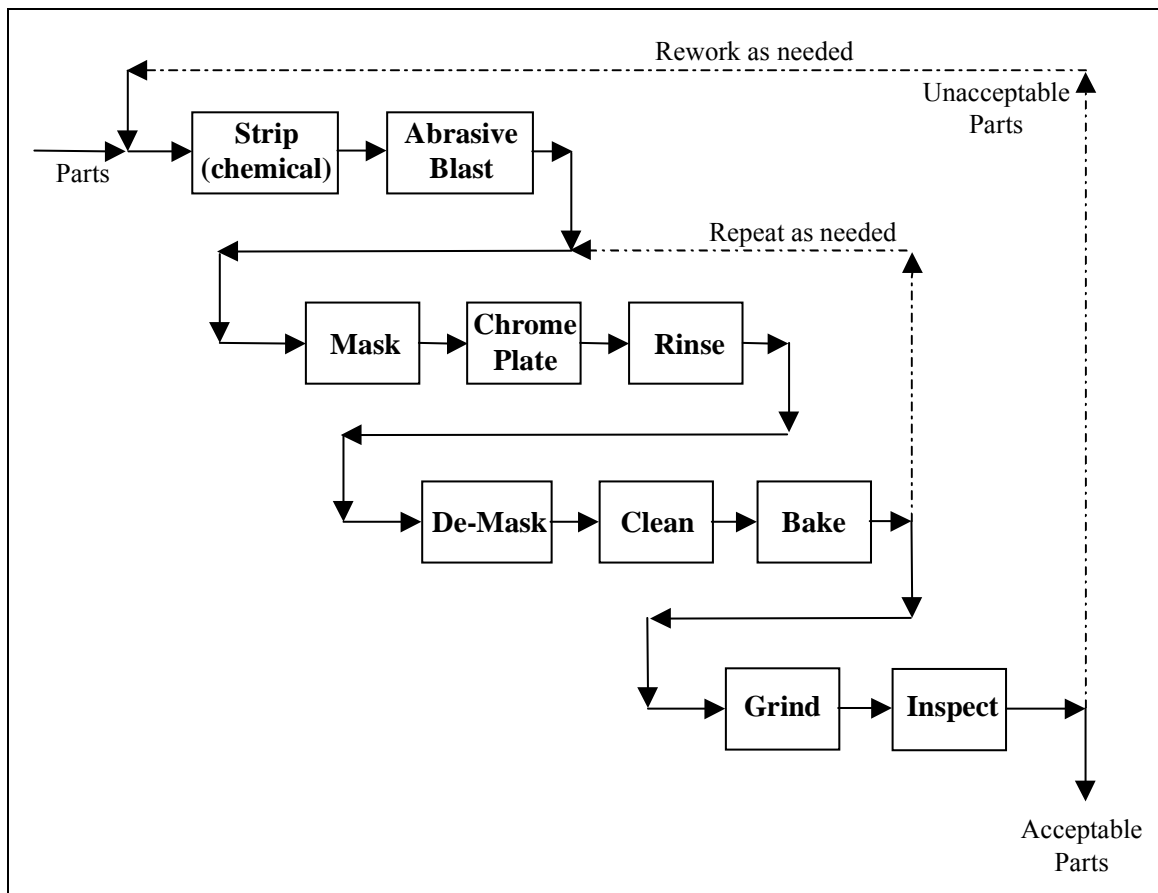
Figure 4-1. Process Flow of Hard-Chrome Electroplating

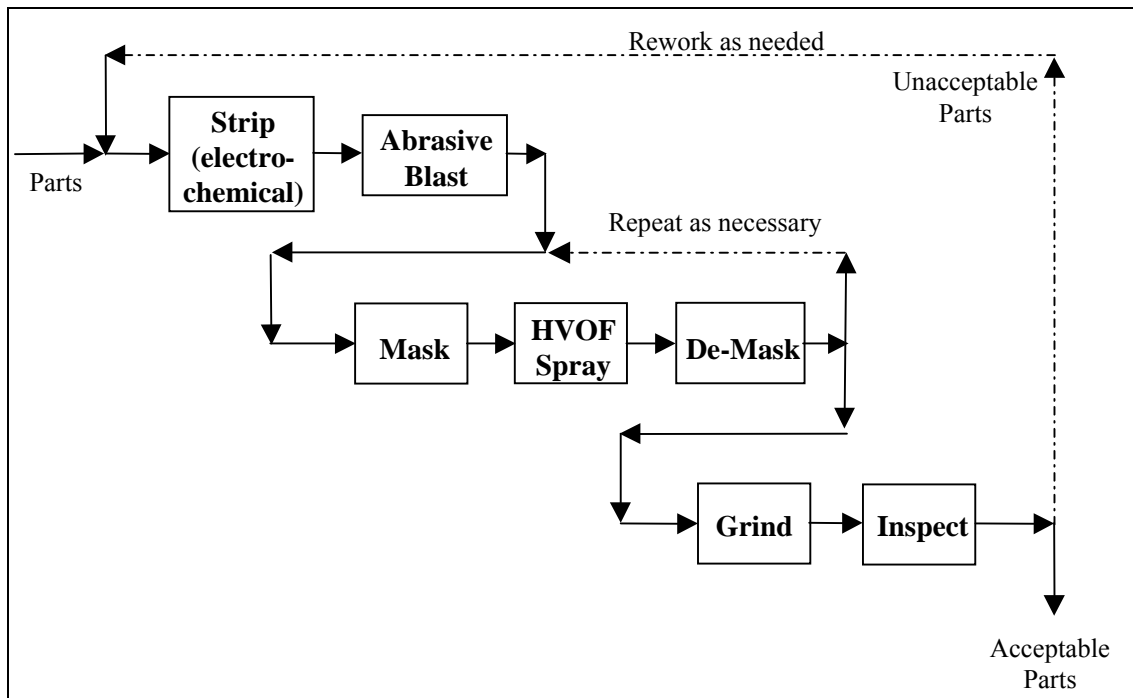
Figure 4-2. Process Flow of HVOF for Applying WC/Co

The collected operating information was used to estimate the potential financial impact of the project, in accordance with the JG-PP CBA Methodology. A process flow diagram relating to the application of WC/Co by HVOF was also developed to aid in analysis of the data. A generic process flow diagram for HVOF WC/Co is shown in Figure 4-2. As with Figure 4-1, rework steps are included because aircraft propeller hubs may be processed more than once to achieve desired coating thickness on specific areas of each component, and because some components may be improperly coated and require rework.
