EVALUATION OF LASER-GLAZED PLASMA-SPRAYED THERMAL BARRIER COATINGS UNDER HIGH TEMPERATURE EXPOSURE TO MOLTEN SALTS

C. Batista^{a,*}, A. Portinha^a, R. M. Ribeiro^a, V. Teixeira^a and C.R. Oliveira^{b,c}

^a University of Minho, Physics Department, Campus de Gualtar, 4710-057 Braga, Portugal,

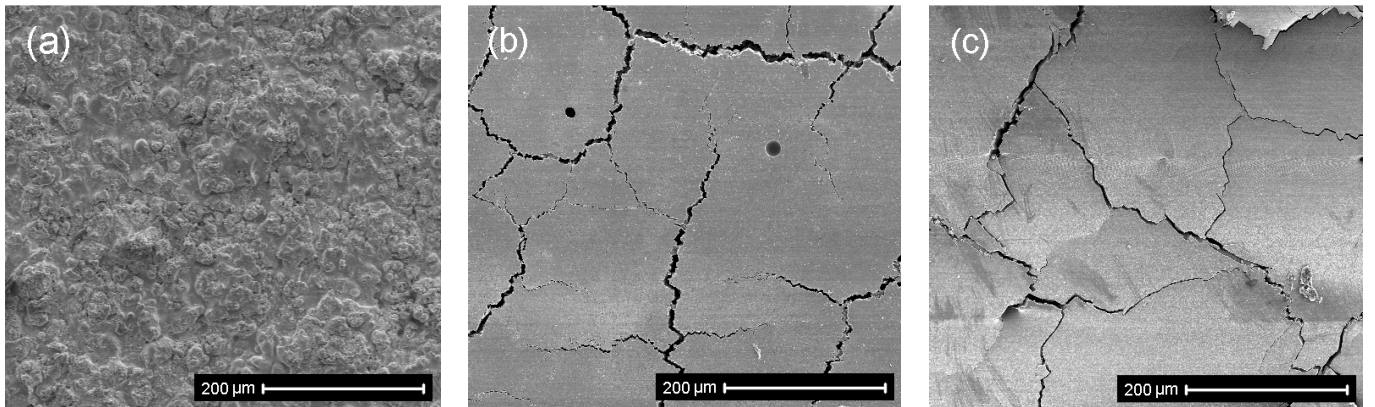
Fig. 1 depicts the initial surface morphology of the TBCs used in the hot corrosion test. Both laser-glazed coatings presented a considerable reduction of the surface roughness if compared with the as-sprayed ones. In addition, the surface porosity was eliminated but a network of cracks perpendicular to the surface has formed in both cases. The crack density is similar in both, however the width of the cracks is substantially smaller in those treated with Nd:YAG laser. Also, voids were found at the surface of the CO₂ laser-glazed coatings while none has been noticed in those treated with the Nd:YAG laser. The microstructure of the glazed layers changed from lamellar to columnar due to the direction of the heat flow on cooling down to room temperature.

Fig. 1. Secondary-electron (SE) micrographs illustrating the surface morphology of the coatings prior to the hot corrosion test; (a) plasma-sprayed condition, (b) laser-glazed with CO₂ laser and (c) laser-glazed with Nd:YAG laser.

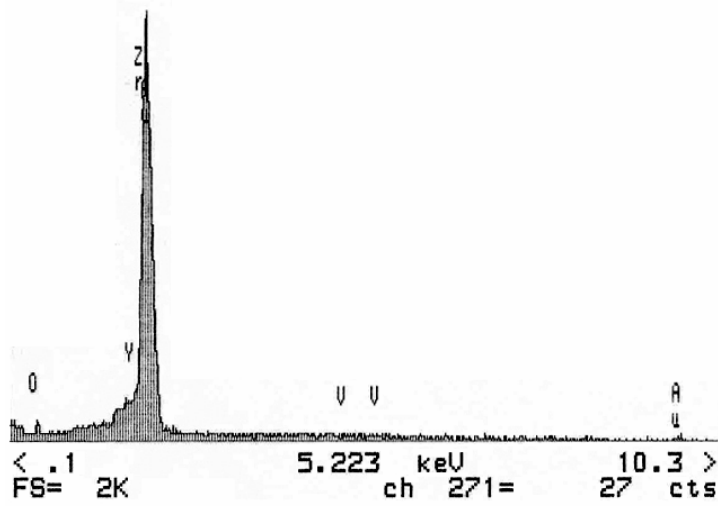
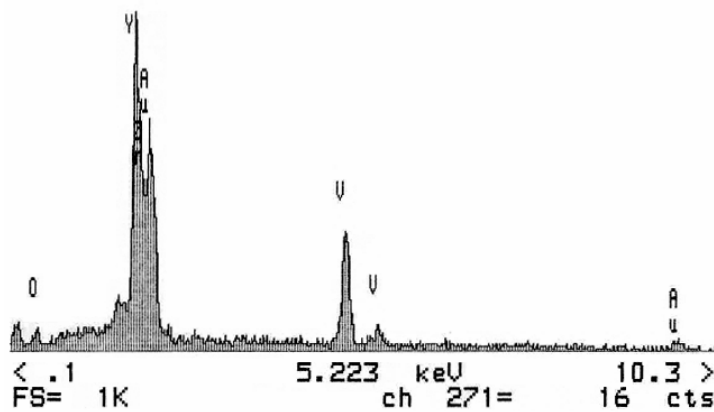
Fig. 3

Fig. 3. EDS spectra acquired from the surface of coating Sprayed-MIX; (a) zirconia matrix, indicated as 2 in Fig 2g, (b) crystal on the surface, indicated as 1 in Fig 2g.
